Australasian Hydrographer

May, 2009

Flood Gauging in the Burdekin River 2009

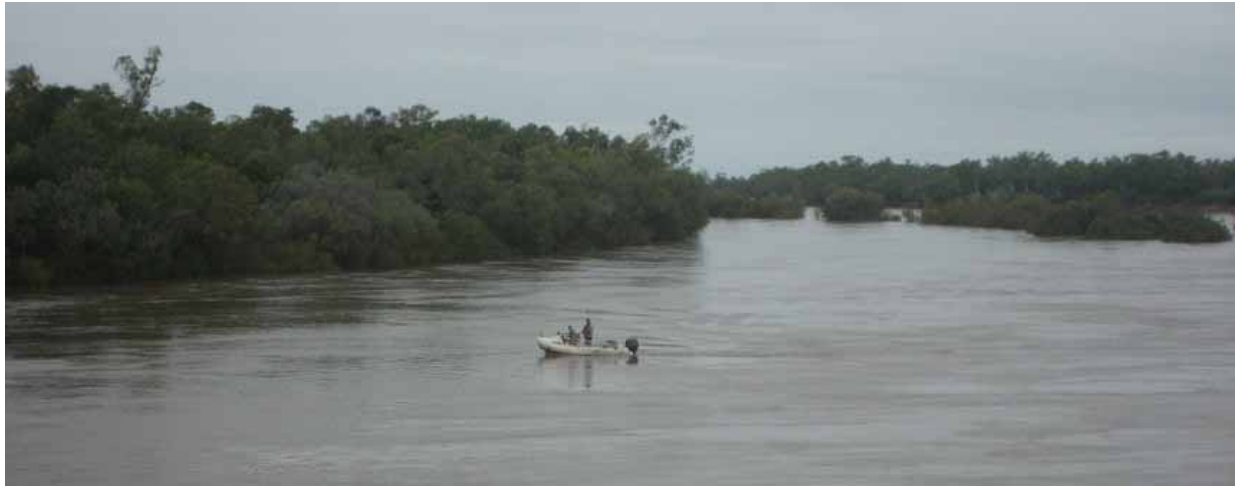
This wet season has been a good opportunity for the hydrographic staff to utilise new ADCP stream gauging technology. This equipment enables staff to measure the flow rate of a river at a point in time. The biggest advantage of this new equipment has been its versatility in a range of flow conditions, as it

can be attached to a boat or a rope to be traversed across a river. Radio communications allow the equipment to record and transmit data, whilst the

operator can remain safely on the bank, an important feature in the Kimberley given the presence of saltwater crocodiles.

Fitzroy River boat gauging

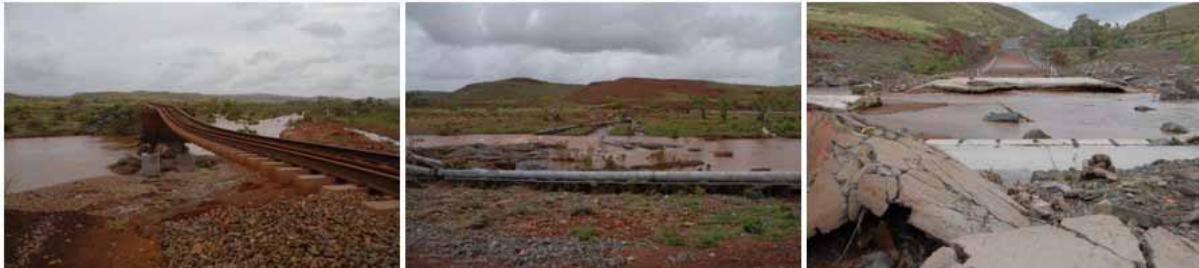
Infrastructure damage due to floods in the Pilbara is common, but each occurrence results in considerable financial losses due to the subsequent disruptions. The mining town of Karratha is the node of activity in the region. The images below show:

- an undercut rail line used by one of the many iron ore mining ventures of the region;

- a broken pipeline that supplies Karratha with its water; and
- one of many roads that were either damaged or cut during the flows.

Flood damage in the Pilbara

Karratha's water supply situation is unique. In dry periods aquifers from Millstream 100 kilometres to the south are used as the water source. The broken pipeline above is the Millstream one. Fortunately, the rainfall also replenished the Harding Dam, Karratha's alternate water source.

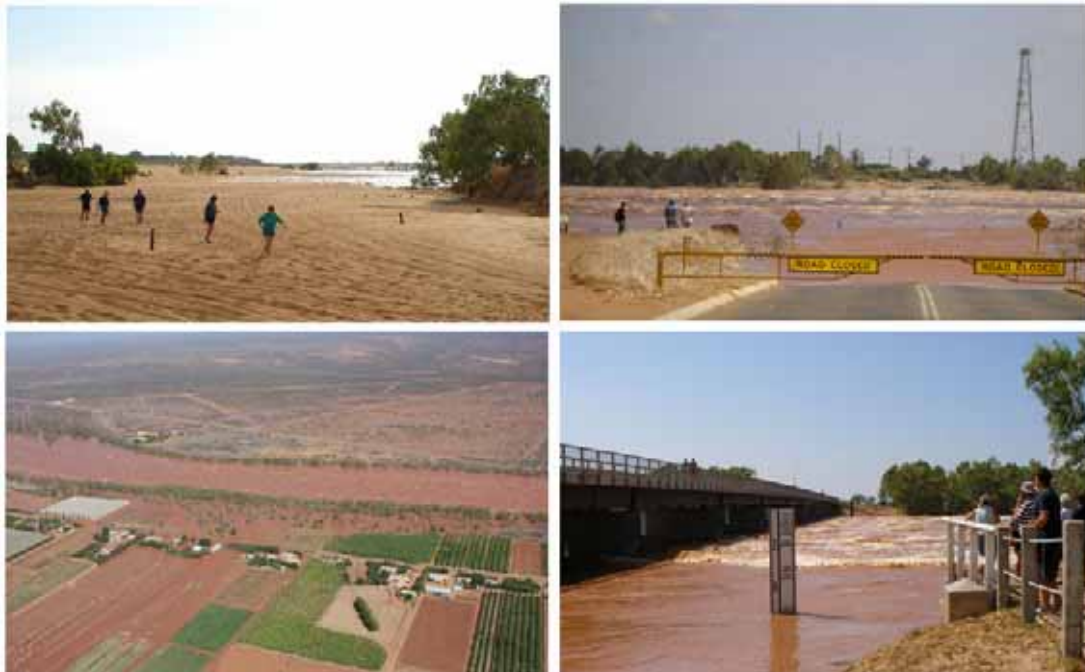
Flood remediation work in Carnarvon has been partly implemented. The bottom right image shows the new bridge that replaced the old single lane bridge (with spectators on) in 2002. With an extra metre or so of height, the new bridge is no longer overtopped, but the approaches are still cut and prevent traffic flow. From a hydrographic aspect, the change in bridge structure has also raised the possibility of a rating change. The dangers of measuring a flow of this nature and the opportunity of it occurring have prevented the collection of sufficient high flow gaugings to complete this task to date.

Gascoyne River flows

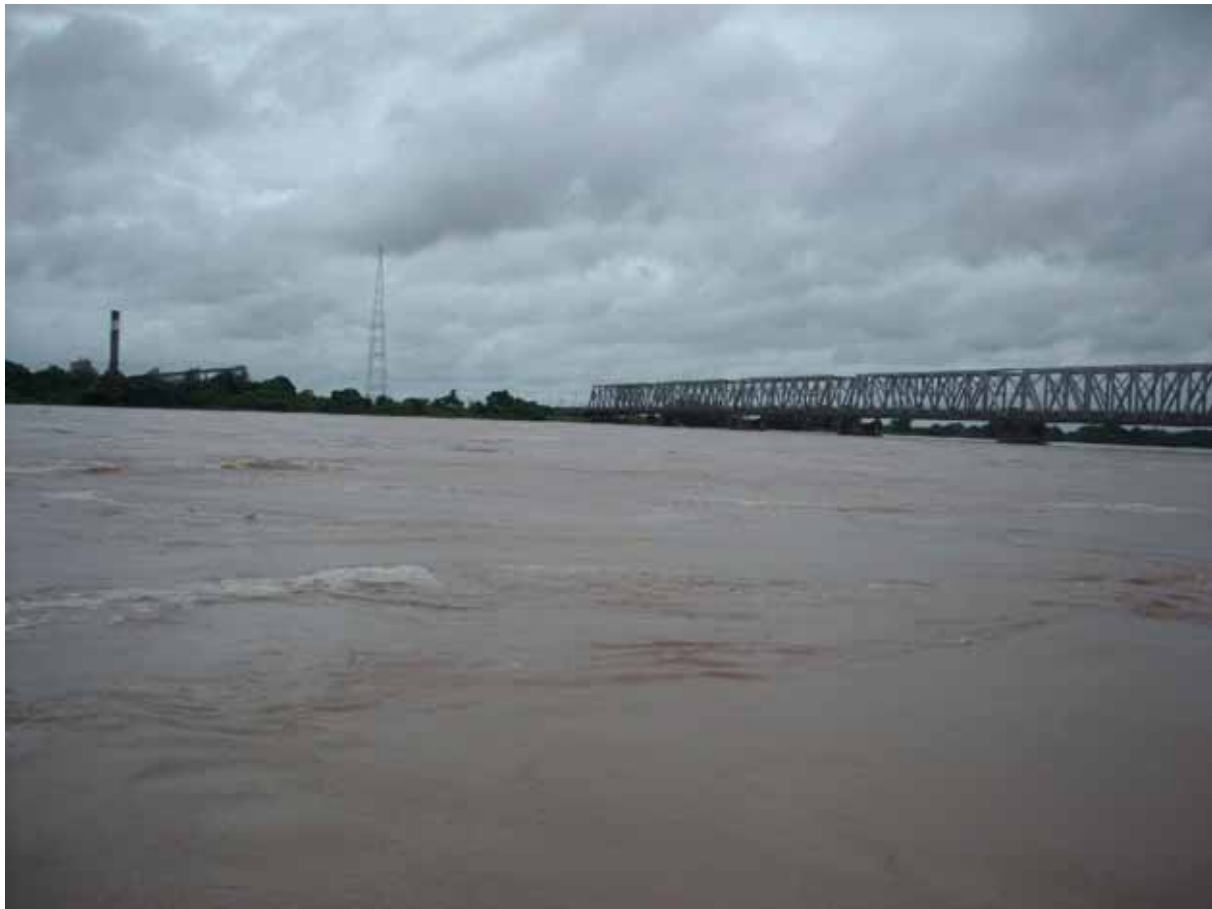
120001A Burdekin R at Inkerman Bridge is a BOM (Bureau of Meteorology) flood warning station and a water sampling site for the Runoff to the Reef sediment and nutrient loads monitoring project. It is located on the Bruce Highway and is the best boat access point into the lower Burdekin River.

120001A Inkerman Bridge, Sugar Mill on right bank

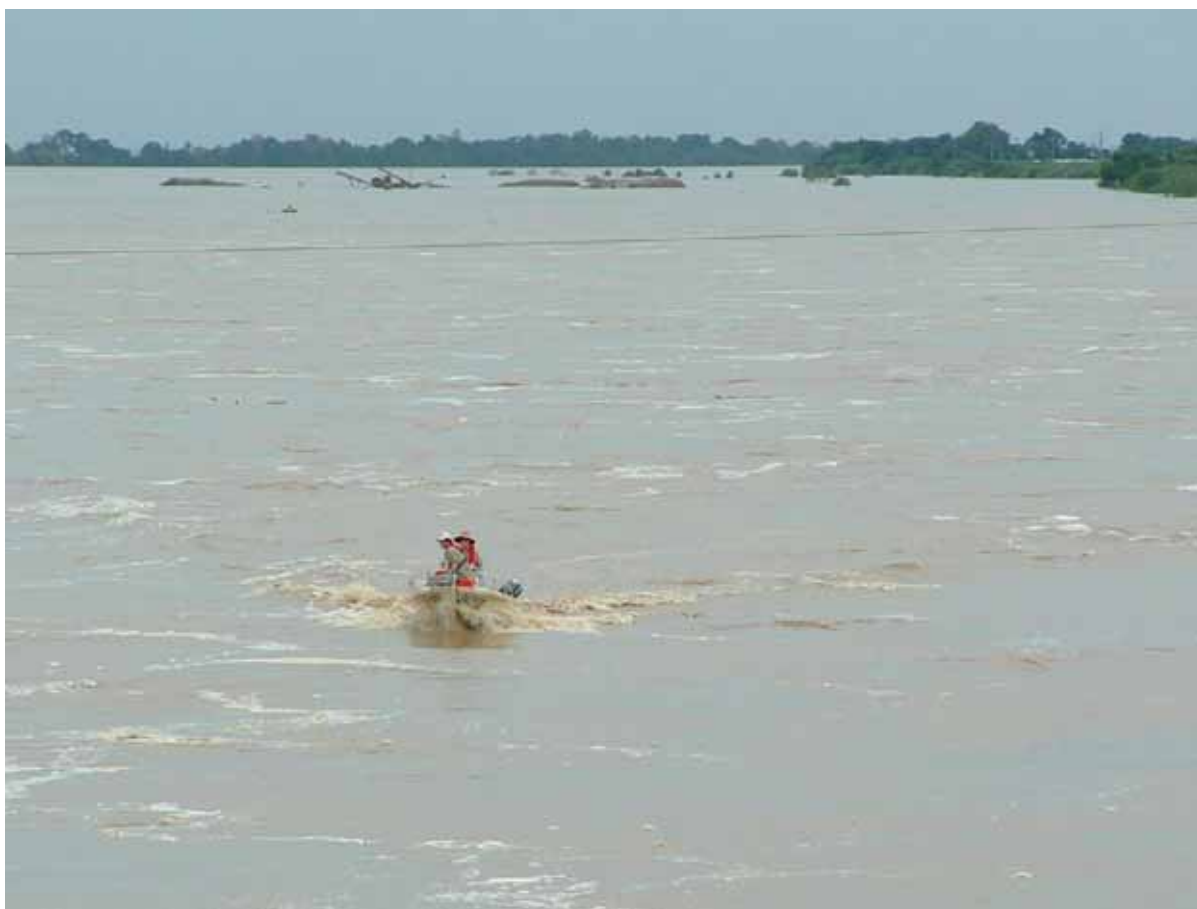
120001A, looking downstream at boat

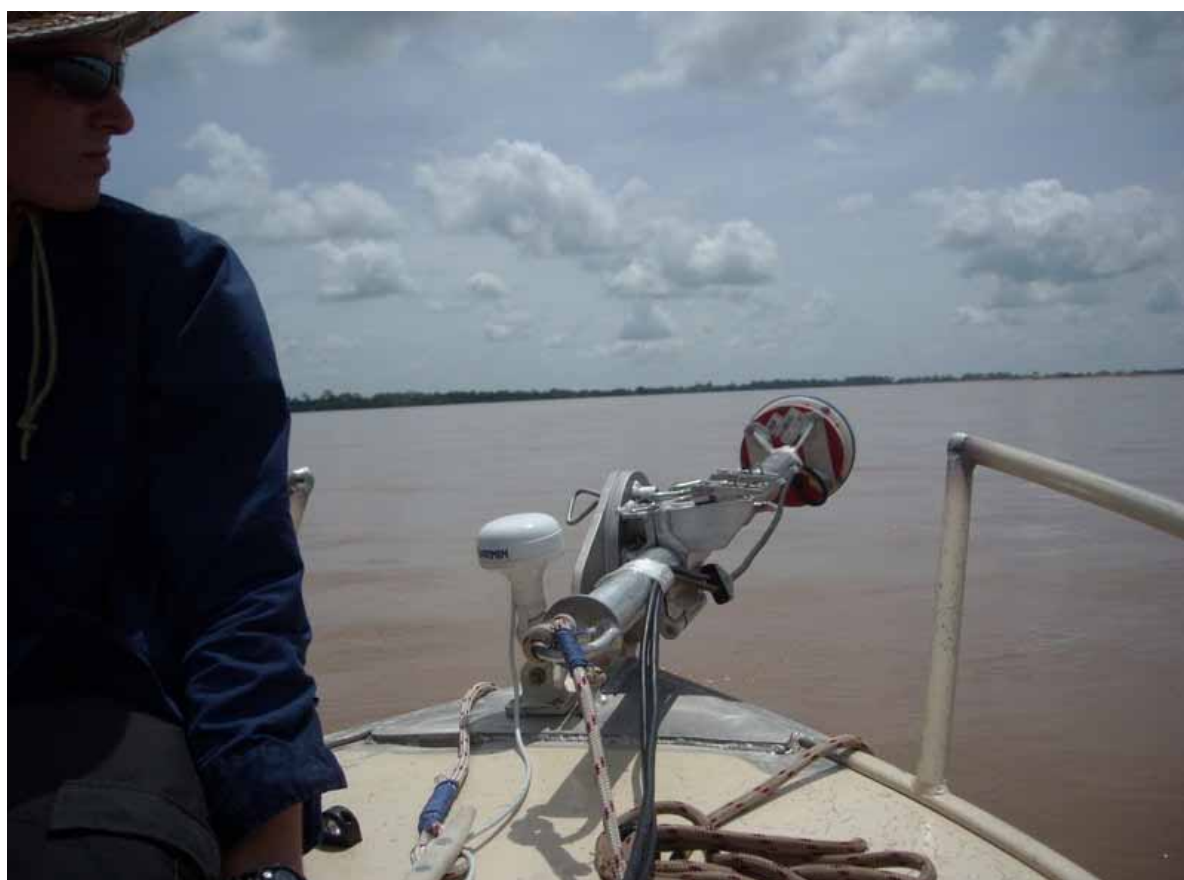
Bow

We used a 600 kHz TRDI Workhorse Rio Grande ADCP with the latest firmware upgrade, a Garmin Map 76 GPS with WAAS (Wide Area Augmentation System) enabled and a Garmin Marine antenna. The antenna was freighted down from Townsville only a day before the highway was cut by flooding.

Mounted Doppler with GPS antenna

The doppler was bow mounted on the centreline of a 4.3m console steer Quintrex v-bottom dinghy. A 40 hp Yamaha outboard provided the power.

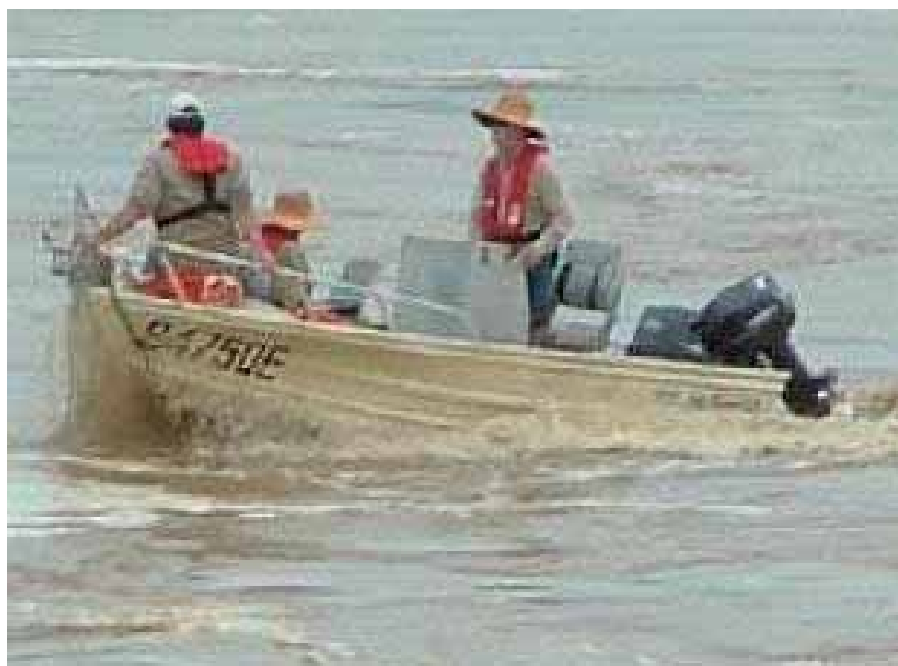
Ayr Flood Gauging Boat 'Caketaker' with crew

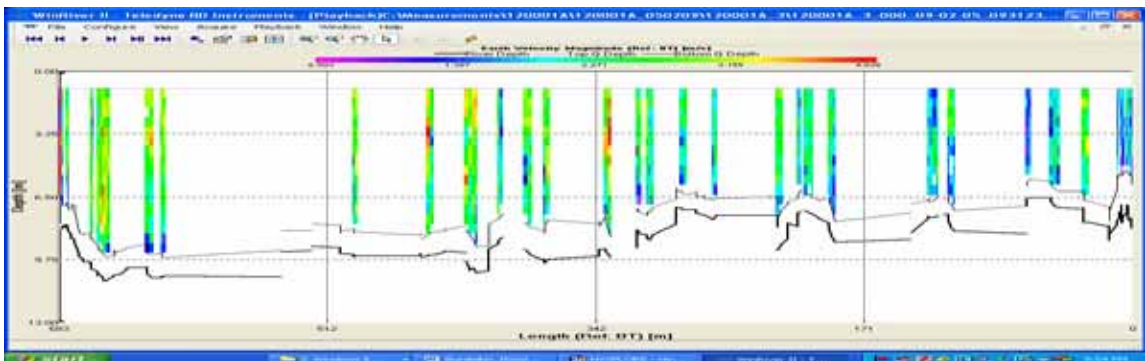
The discharge was 25% less without the GPS and commands and 4.5% less with the GPS only.

120001A 05.02.09 Transect 0 with no GPS and no Additional Commands

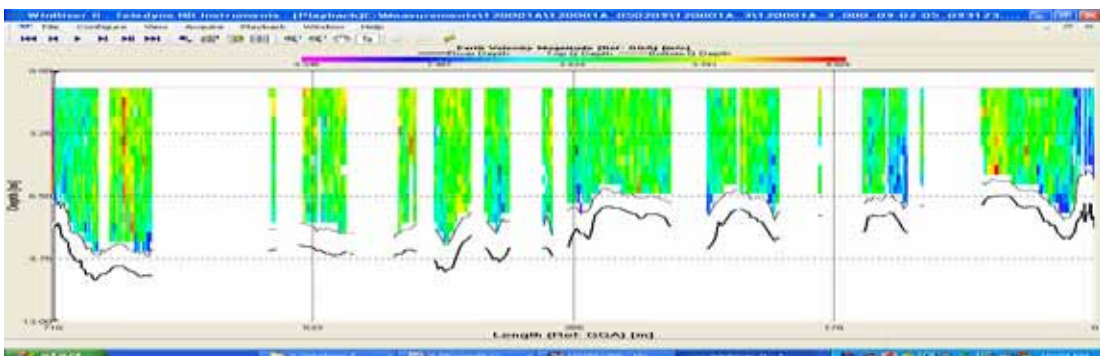
120001A 05.02.09 Transect 0 with GPS only

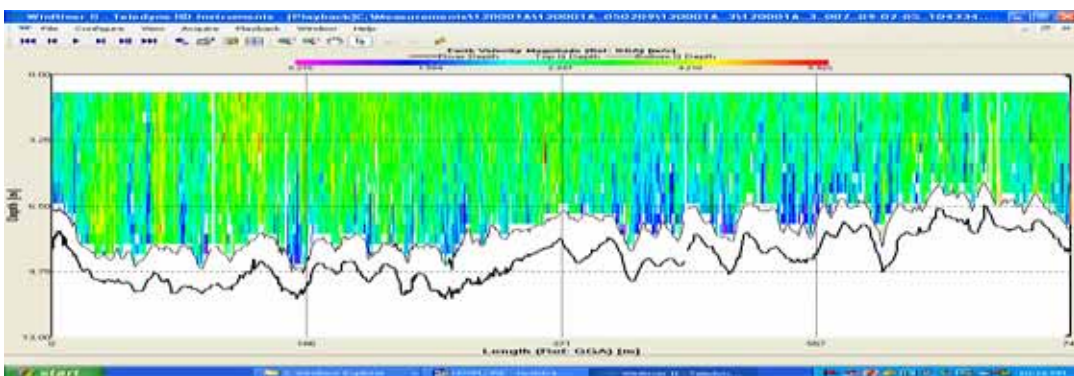
Extremely fluid bed conditions also led to the rejection of a significant proportion of the bottom track and velocity data. We were able to overcome this by using the 3 Beam Solutions and altering the BA, BC and WC values in the Commands page.

120001A 05.02.09 Transect 2 with GPS and BA, BC and WC commands and 3-beam solutions

BA, or Bottom Elevation Amplitude, sets the minimum value for valid bottom detection. Decreasing BA can improve bottom track range in adverse conditions but can also increase false bottom detections. I used a value of between BA 15 and BA 20 with no problems.

BC and WC are the Bottom Correlation and Water Correlation thresholds below which bottom track and water velocity data is flagged as bad and not included. I used values of between BC 125 and BC 150 and WC 025 and WC 050. I selected Water Mode 1 and Bottom Mode 4 as they are the most robust modes in turbulent, high flow conditions.

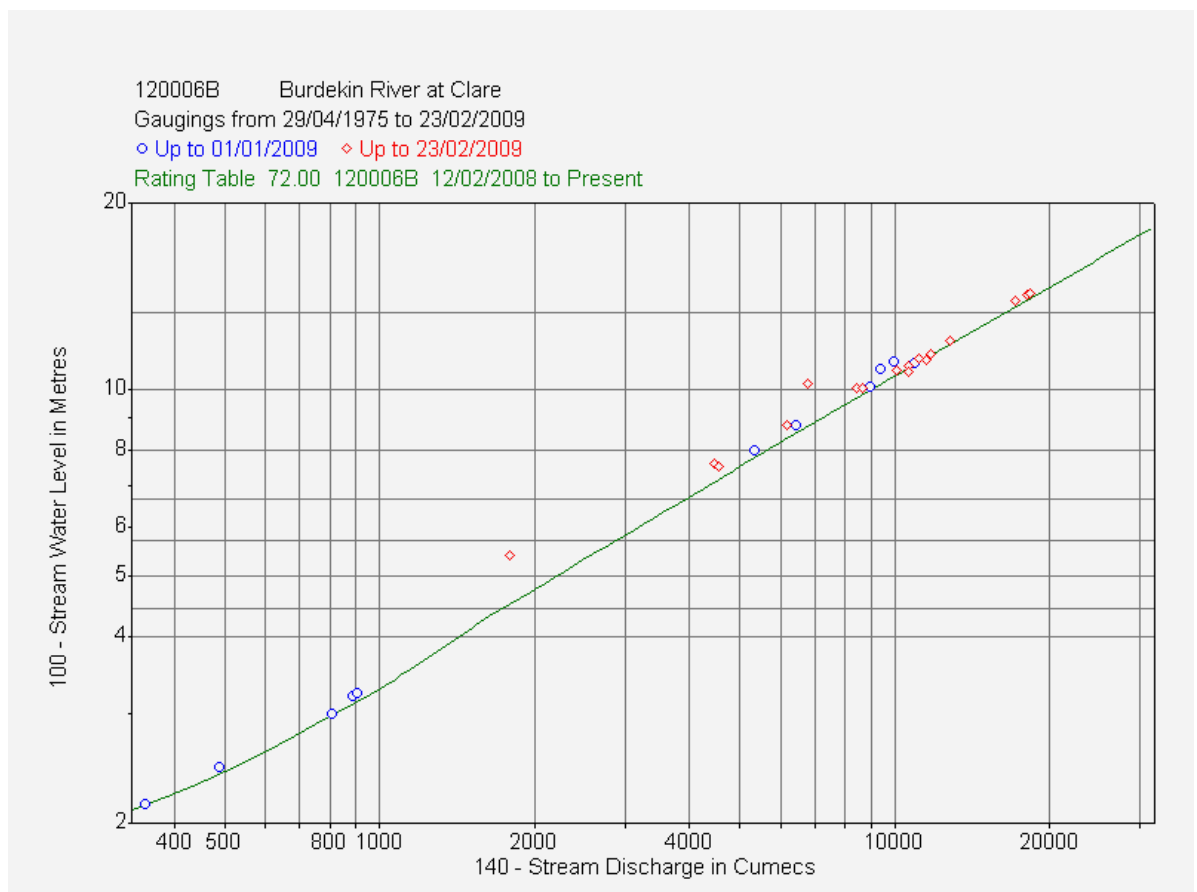
The lowest measurement in the series also plots off the curve, though the other measurements suggest a possible change in slope of the curve in this area. Further measurements are required in the 1000 to 4000 cumec range.

The two older measurements that plot off the curve were 2008 doppler measurements affected by moving bed error.

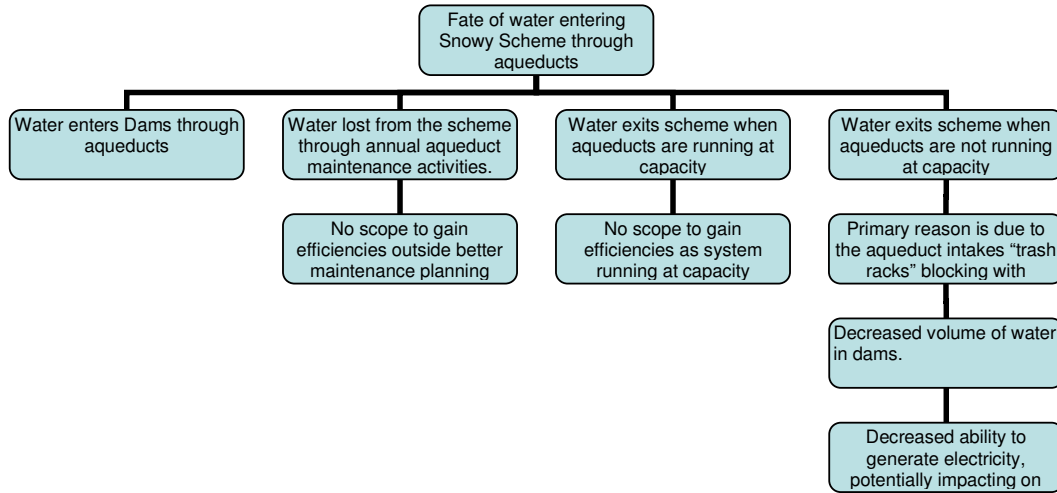
Figure 1: Flow Chart of Fate of Water Entering Aqueduct

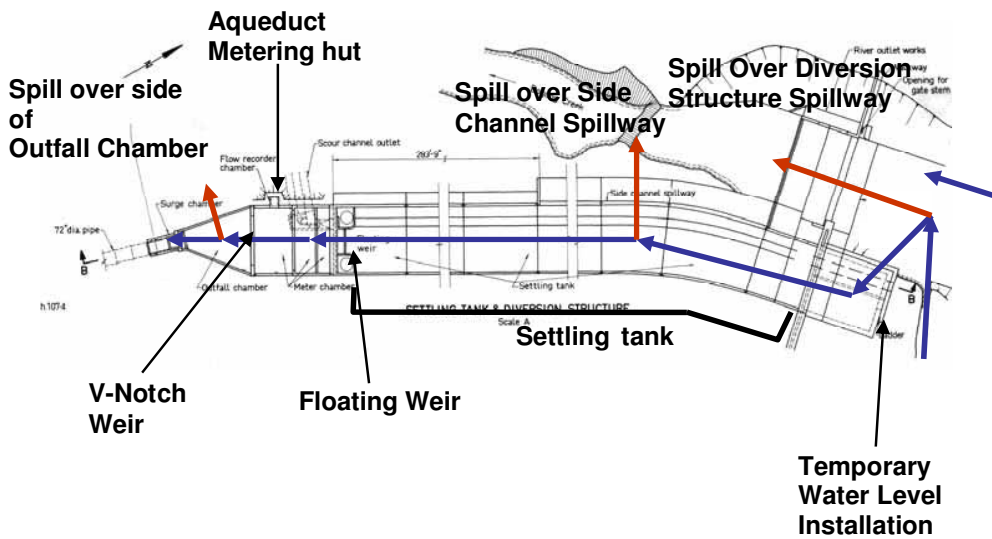
The Bourkes Gorge Aqueduct diversion structure (Figures 4) is arranged with an intake structure that impounds water from the Bogong and Grey Mare creeks. The water is then diverted through the trash racks into the settling tank. Water flows through the settling tank and under a floating weir which regulates the amount of water flowing into the meter chamber. The water level in the meter chamber is regulated by a large v-notch weir which has a rating table that was derived upon construction. The rating table is used to determine flows entering the aqueduct.

Water can finally be lost from this structure over the side of the outfall chamber (final chamber before entering the aqueduct). This only occurs when the aqueduct is full and no more water could enter.

Figure 4: Bourke's Gorge Diversion Structure and Settling Tank Arrangement
 Source: SHL Drawing No # 34502A, 1966

Through the whole structure, water spilt over the diversion structure spillway when the aqueduct is not running at full capacity is the only water that has any potential to be saved. The water level instrumentation was therefore installed in the intake structure where water level was recorded and relative levels surveyed to identify spillway level.

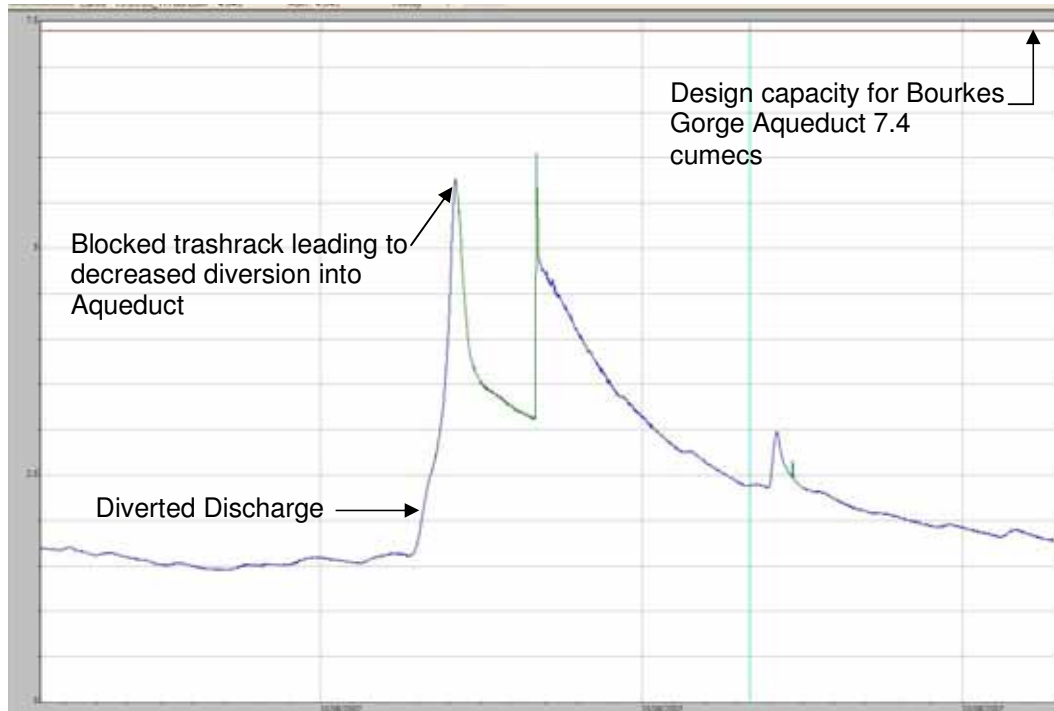
Figure 5: Discharge Hydrograph of water diverted into Bourkes Gorge Aqueduct. Generated from HYDMWB for aqueduct monitoring station (600175).

Figure 5 shows the discharge hydrograph of the spill event that occurred on 12 August 2007. Several features of the event are evident:

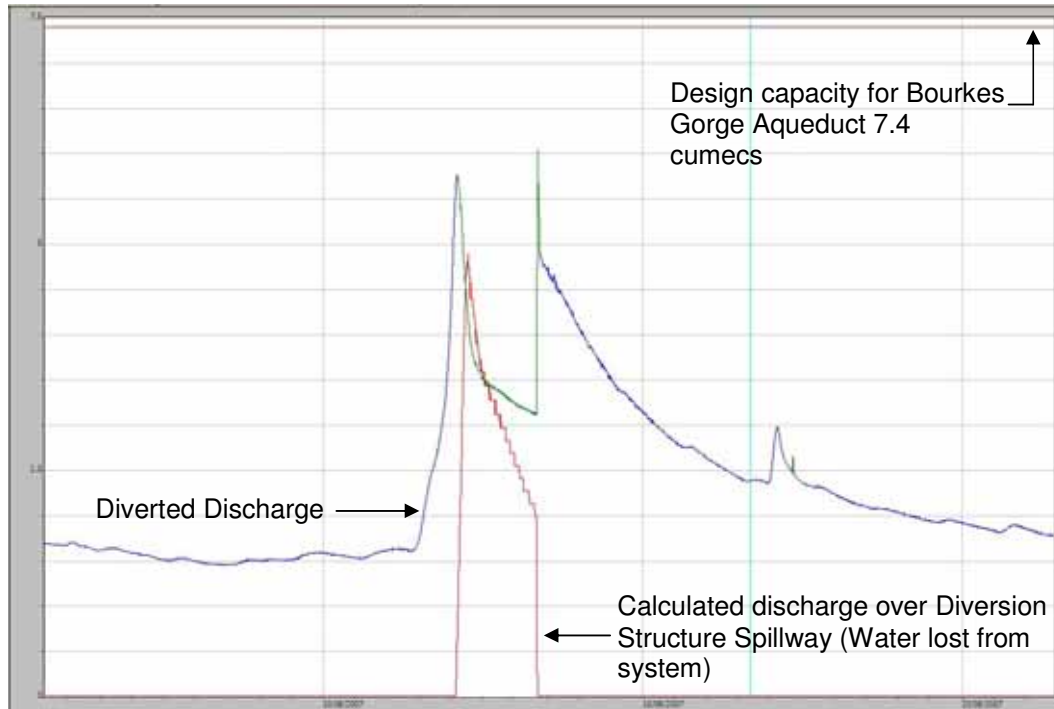
Figure 6 below shows the discharge for diverted water and discharge over spillway as separate traces and Figure 8 combines the

Figure 6: Discharge Hydrograph for Rainfall Event Bogong Creek 12 August 2007 - Diverted and Spill Discharges shown.

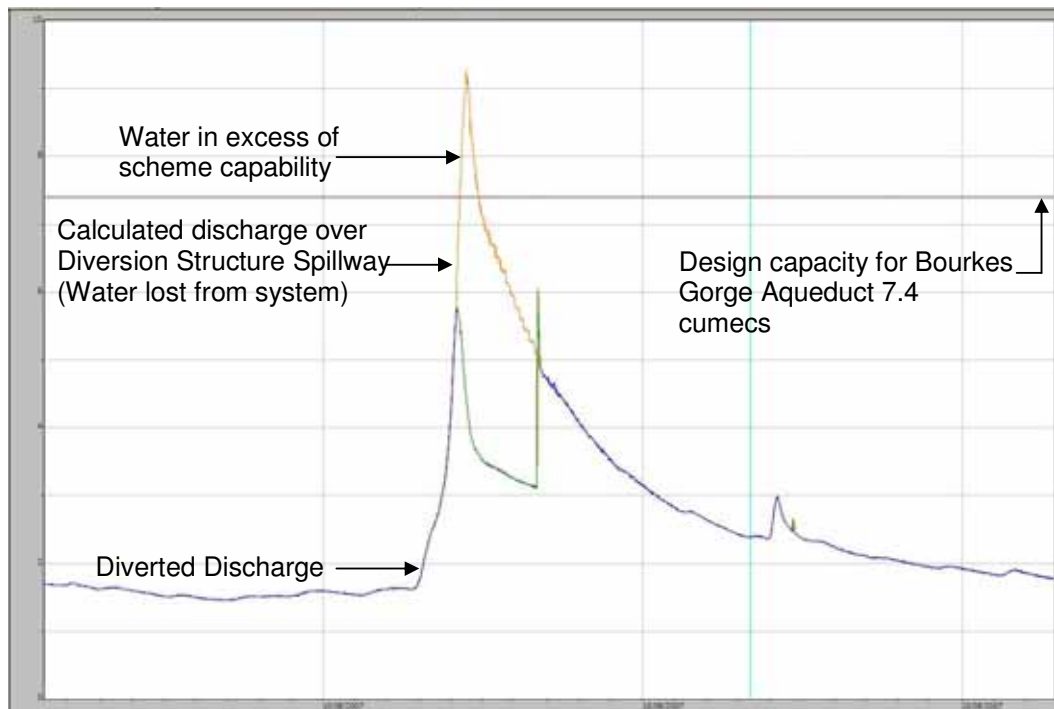
Figure 7: Total Discharge Hydrograph for Rainfall Event Bogong Creek 12 August 2007 - Diverted and Spill Discharges combined

Figure 7 shows a trace combining diverted and spilt water, creating an instantaneous total discharge for water that would be entering the intake structure before the trash racks.

- Total discharge exceeded aqueduct capacity
- Part of the flow would have been unable to have been diverted for SHL purposes.
- A large percentage of discharge was spilt and lost from the system.

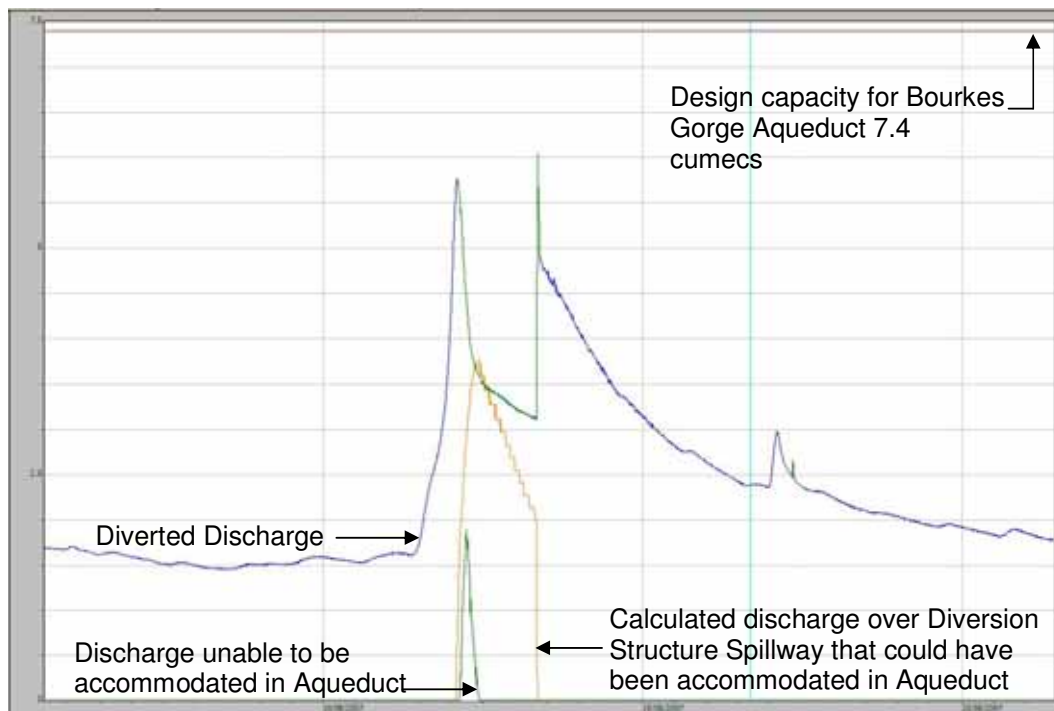
To separate the parts of the flow, the total discharge hydrograph for Bogong creek as seen in Figure 8 has all flow below capacity subtracted from the total, leaving the part in excess of aqueduct capacity. This is then subtracted from the spill hydrograph, using HYCRSUM, resulting in a hydrograph for diverted water, spilt water that could have been diverted and spilt water that was in excess of the scheme capacity (see Figure 8 below).

Figure 8: Discharge Hydrograph for Rainfall Event Bogong Creek 12 August 2007

By running a HYDAY on the separate segments of Figure 8 above, daily volumes for the period of the spill event were determined as:

- 332ML was the total discharge spilt
- 308 ML in total lost that could have been diverted
- 24 ML Outside Structure Capacity/would have occurred as natural spill.

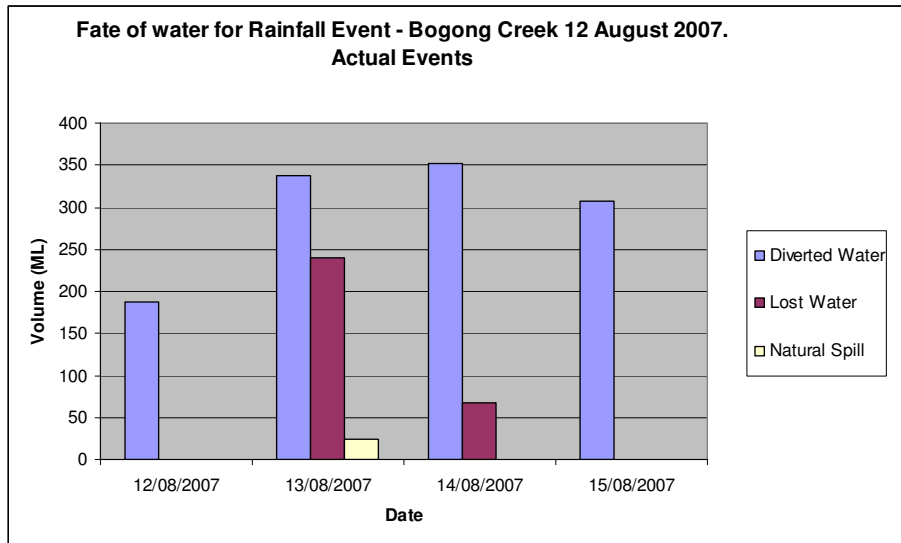
Figure 9: Daily Discharge Volumes, Separated into Final Destination

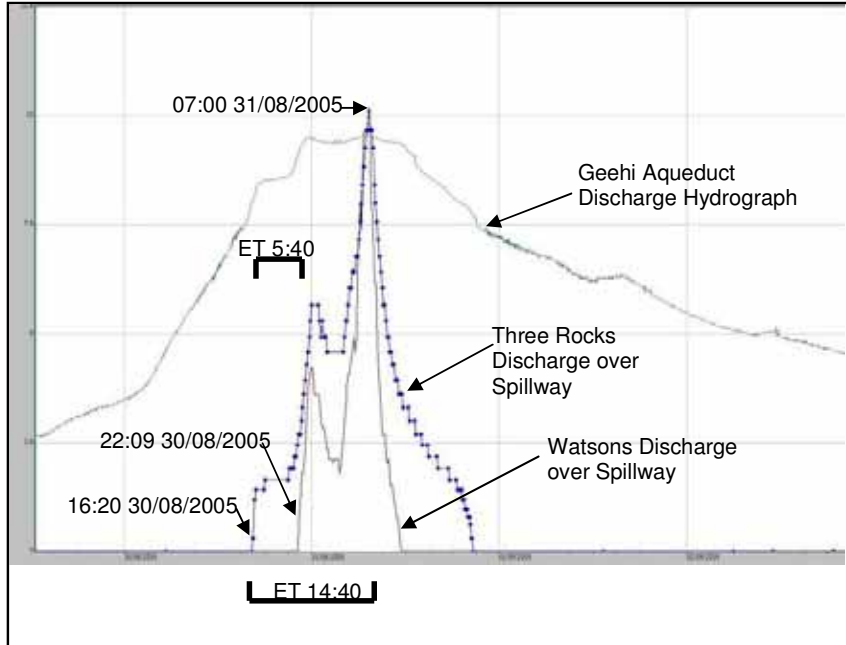
Rocks Spills much earlier than Watsons (5-6 hours on large spills) as illustrated in Figures 10 and 11 below. Figures 10 and 11 both show the timing of events and Elapsed Time

(ET) between peaks in the hydrograph. They also highlight the ET between onsets of spilling at the two sites.

Figure 10: Geehi Aqueduct Discharge Hydrograph and Timing of Diversion Structure Spills.

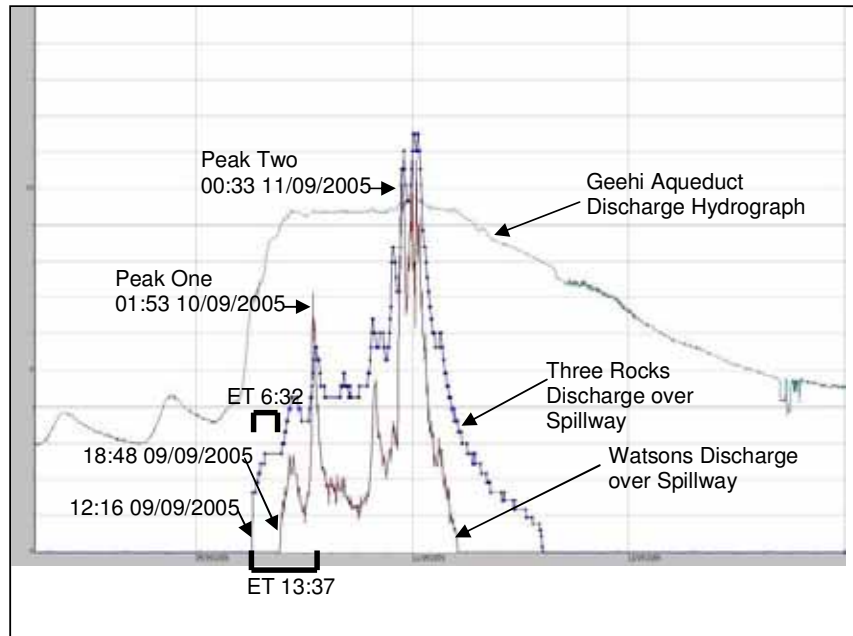
Figure 11: Geehi Aqueduct Discharge Hydrograph and Timing of Diversion Structure Spills

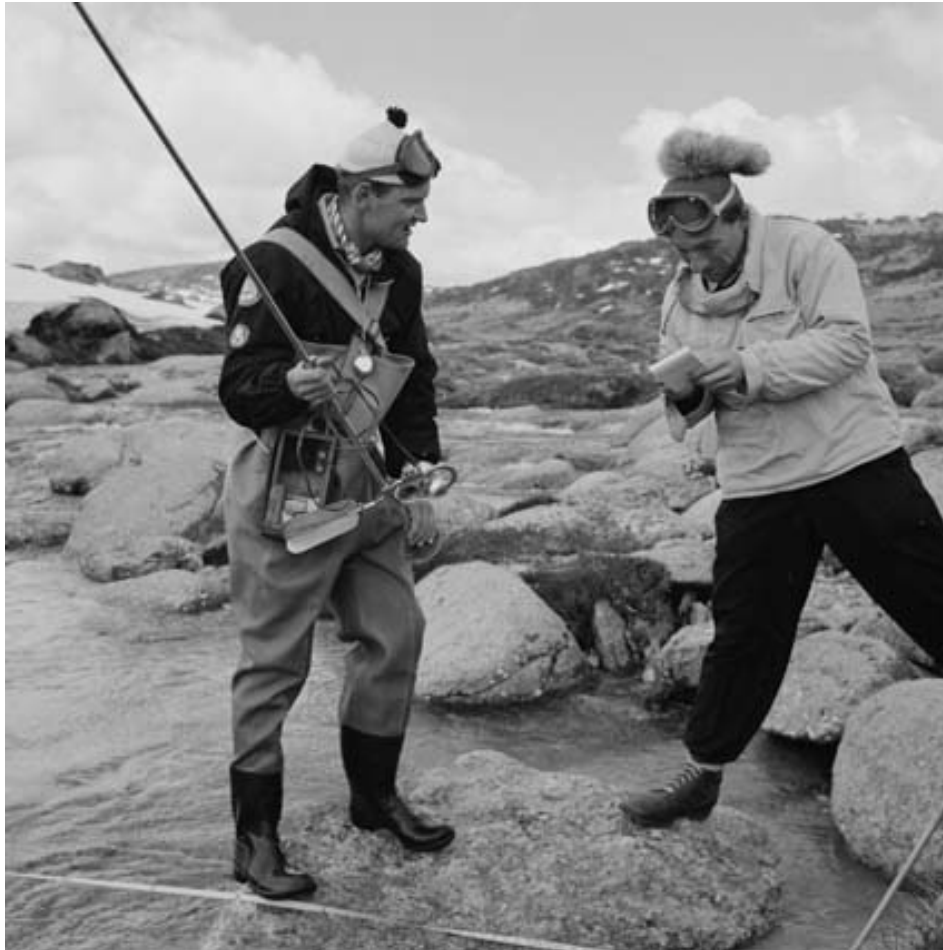
Gauging in the Snowy Mountains Alpine catchments. (SMA Collection)
