# Australasian Hydrographer September 2019

AUSTRALIAN  
HYDROGRAPHERS  
ASSOCIATION

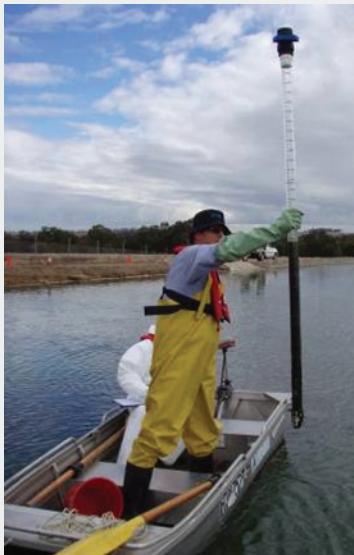
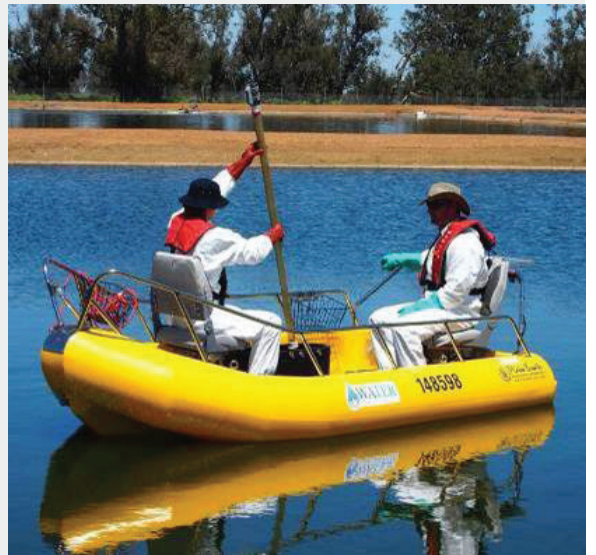
Figure 1: Water Corporation Hydrographers undertaking Sludge Profiling.

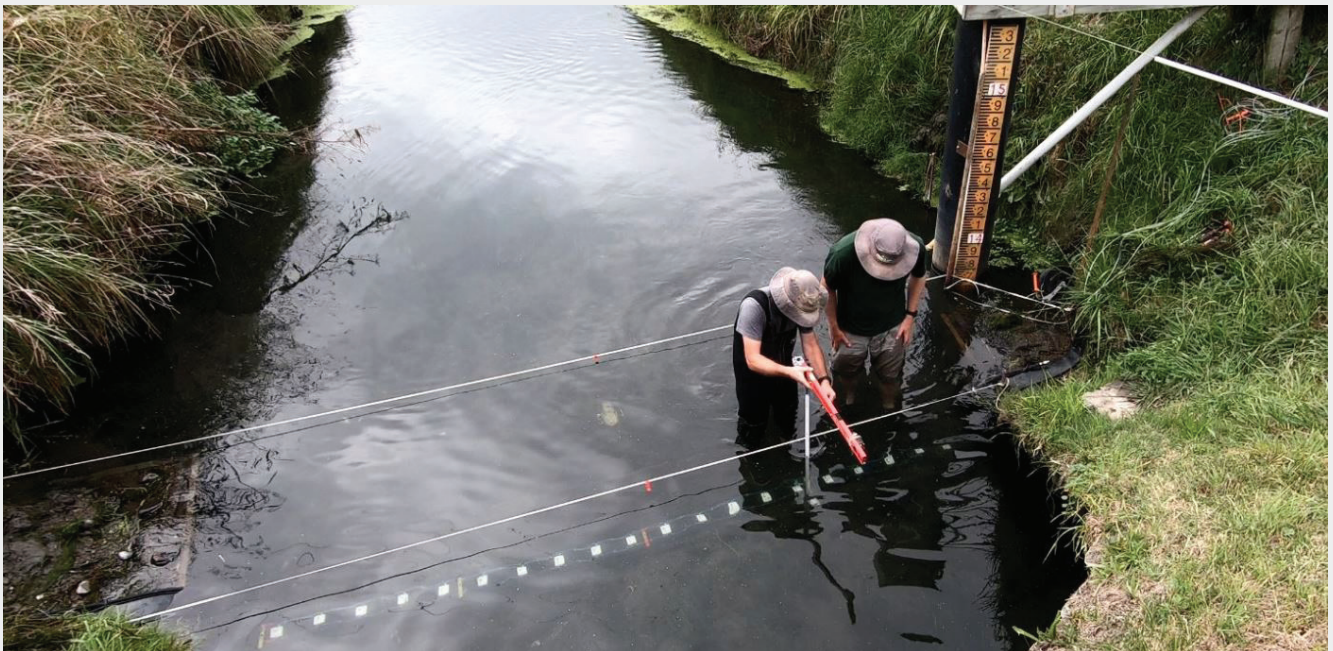
Figure 1: Paul Hodgkinson and Thomas Wilding (HBRC) deploy the bubble line within the Raupare Stream.

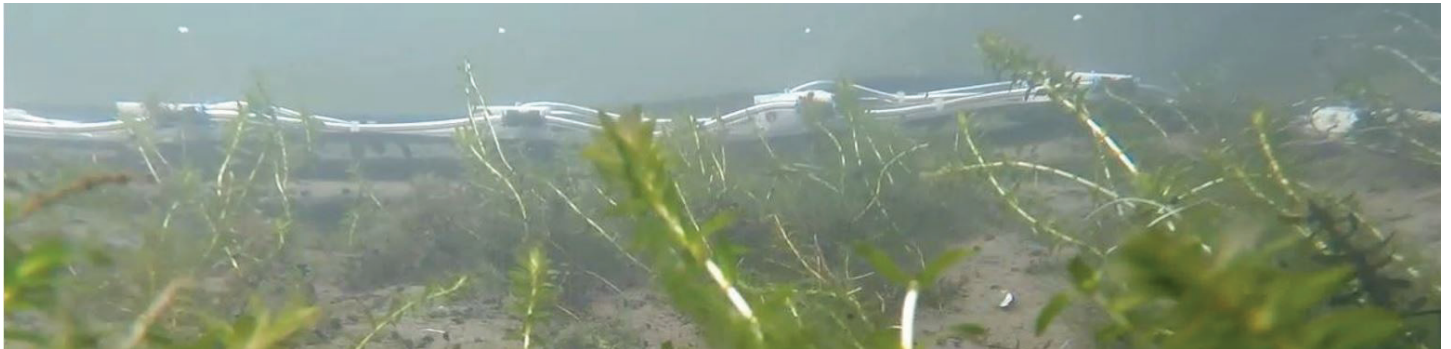
60 frames per second). A single bubble was injected simultaneously from each of the 20 injectors to release a line of bubbles at the streambed across the width of the stream. This was repeated nine more times (every 1.7 seconds). Each of the 10 snapshots gave an instantaneous value for Q.

Figure 2: Underwater view showing each injector simultaneously releasing a single bubble.

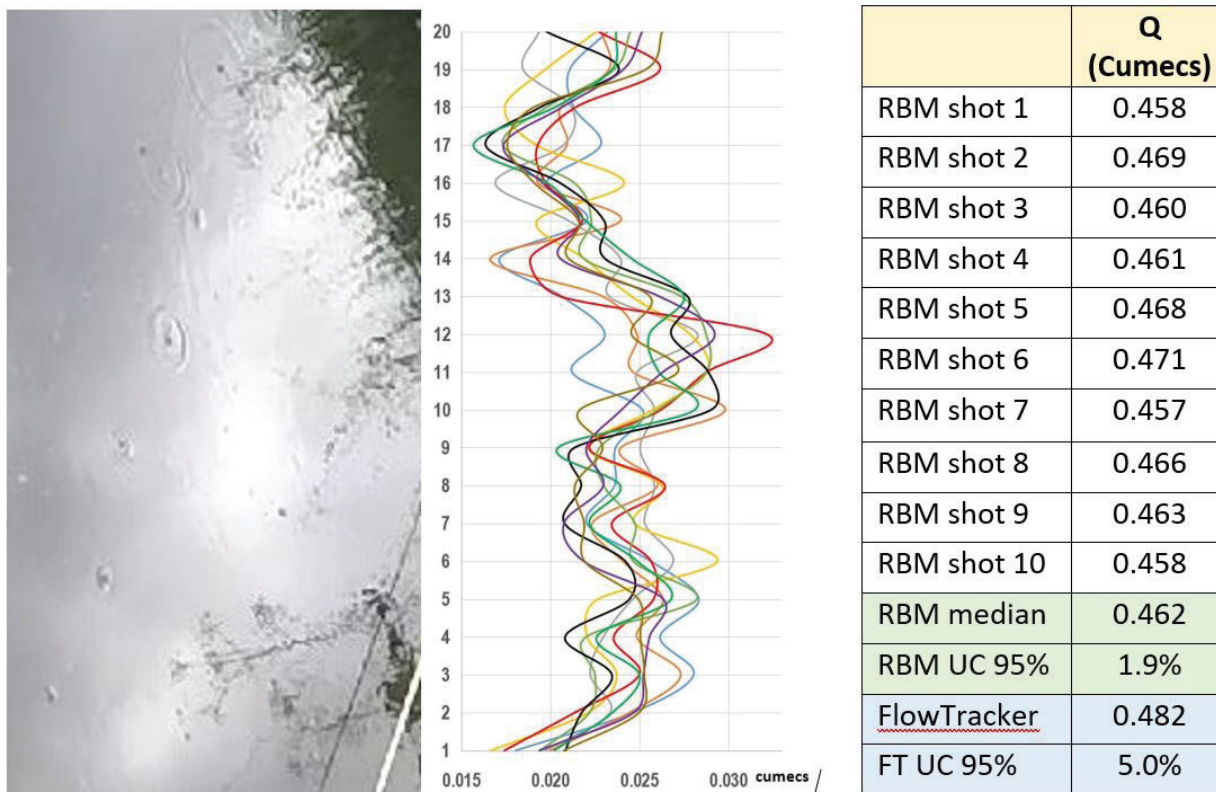
Figure 3: Left - bubbles surfacing. Middle - colour-coded chart depicts the partial discharge that each of the 20 injectors contributed to Q showing how the flow rate (not the velocity) varied across the stream width. Right - results from 10 'flow-shots', producing 10 near-instantaneous snapshots of Q.

Less than a second elapsed between the earliest and latest bubbles to 'just surface' within each sequence with the difference depending on the depth. The mean depth was 0.6 m. Our reference was a Sontek FlowTracker, sampling at 20, 60 and 80% of depth every 0.2 m.

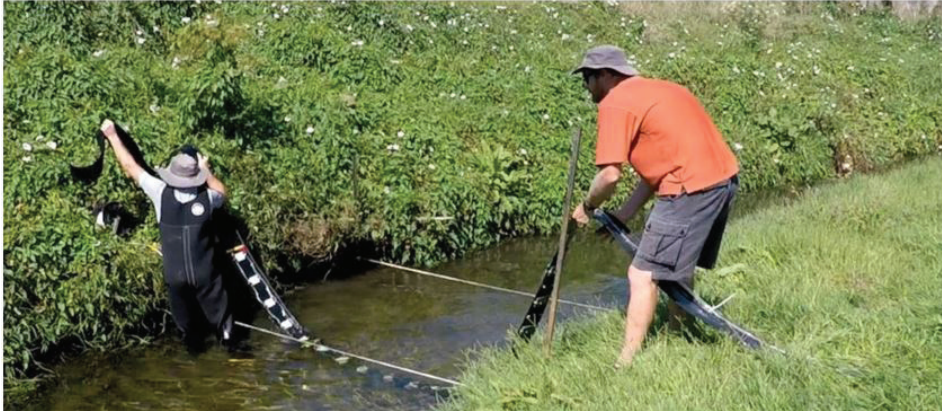
Q (Cumecs)
RBM shot 1	0.133
RBM shot 2	0.134
RBM shot 3	0.135
RBM med'n	0.134
Flowtracker	0.132

Figure 4: Left; Paul Hodgkinson and Thomas Wilding (HBRC) deploy the bubble line at Karewarewa Stream. Thomas did a lot of clearing and weeding on his previous visit to enable FlowTracker measurements. Right; snapshots of total discharge show good repeatability and agreement with the reference.

The same bubble line was installed in the Karewarewa Stream. This stream also located within the Karamu catchment, New Zealand. The site receives groundwater via a 4 m thick layer of pumice sand, which is an alluvial deposit from a Taupo eruption. The low gradient and lack of shade allows prolific weed growth.

Since this stream is narrower than the Raupare, only 13 of the 20 bubble injectors were underwater.

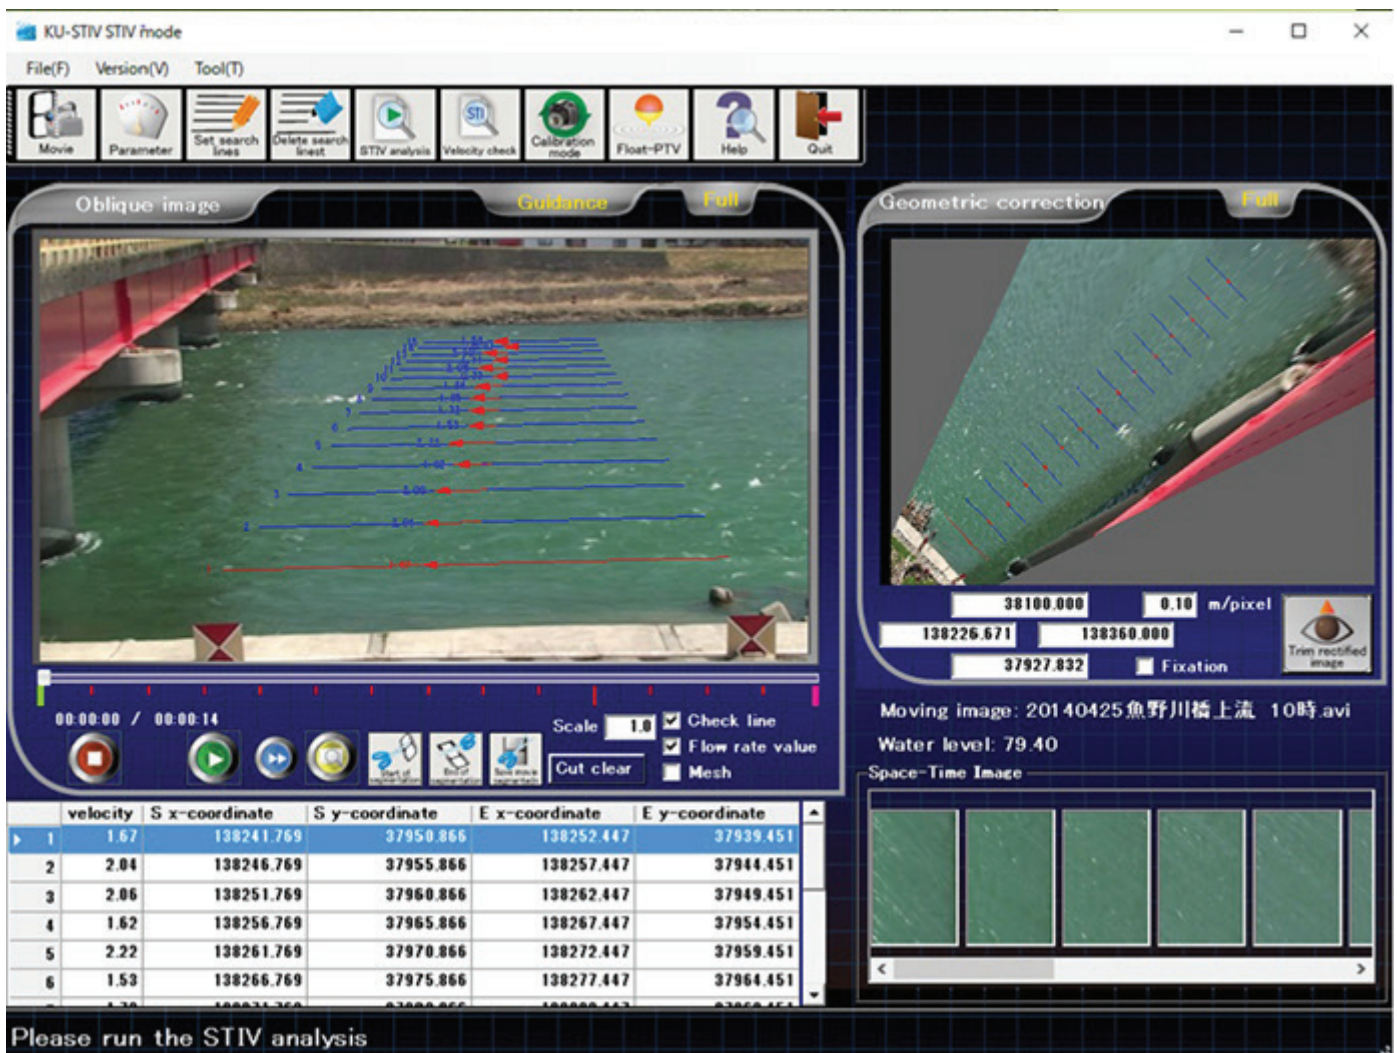
Figure 1: A screen shot from KU-STIV software.

- Orthorectification of the video imagery (removing the effect of perspective and creating a 2D image area for analysis);
- Superimpose “searching lines” (each between 10 and 20 metres long) on footage of the river as measurement standards;
- Calculates the water’s surface speed from the time it takes water surface features and floating matter on the surface of the river to move through these lines;
- Analyse velocity distribution, with suitable ‘alpha’ co-efficients, to indirectly calculate the river flow rate.

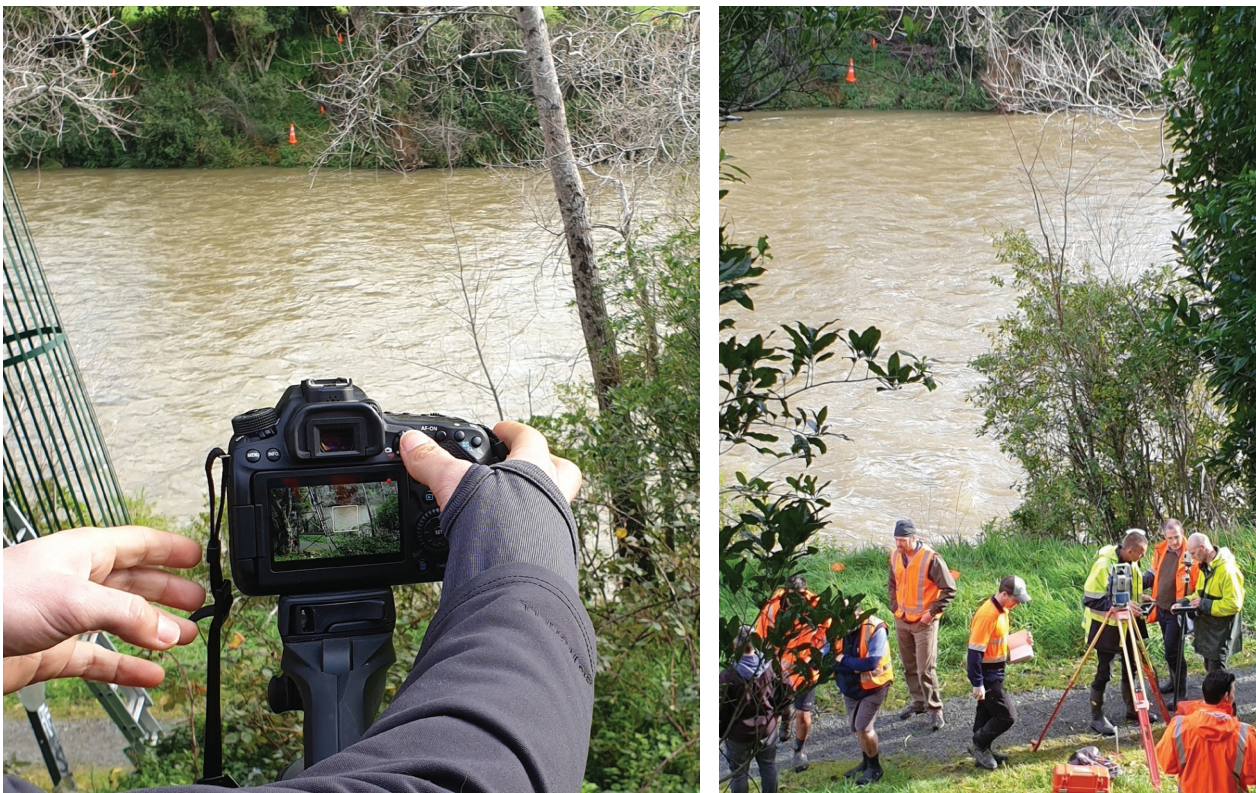
Figure 3: Left, “Fixed” camera installation setup. Right, Total Station survey of ground control points.

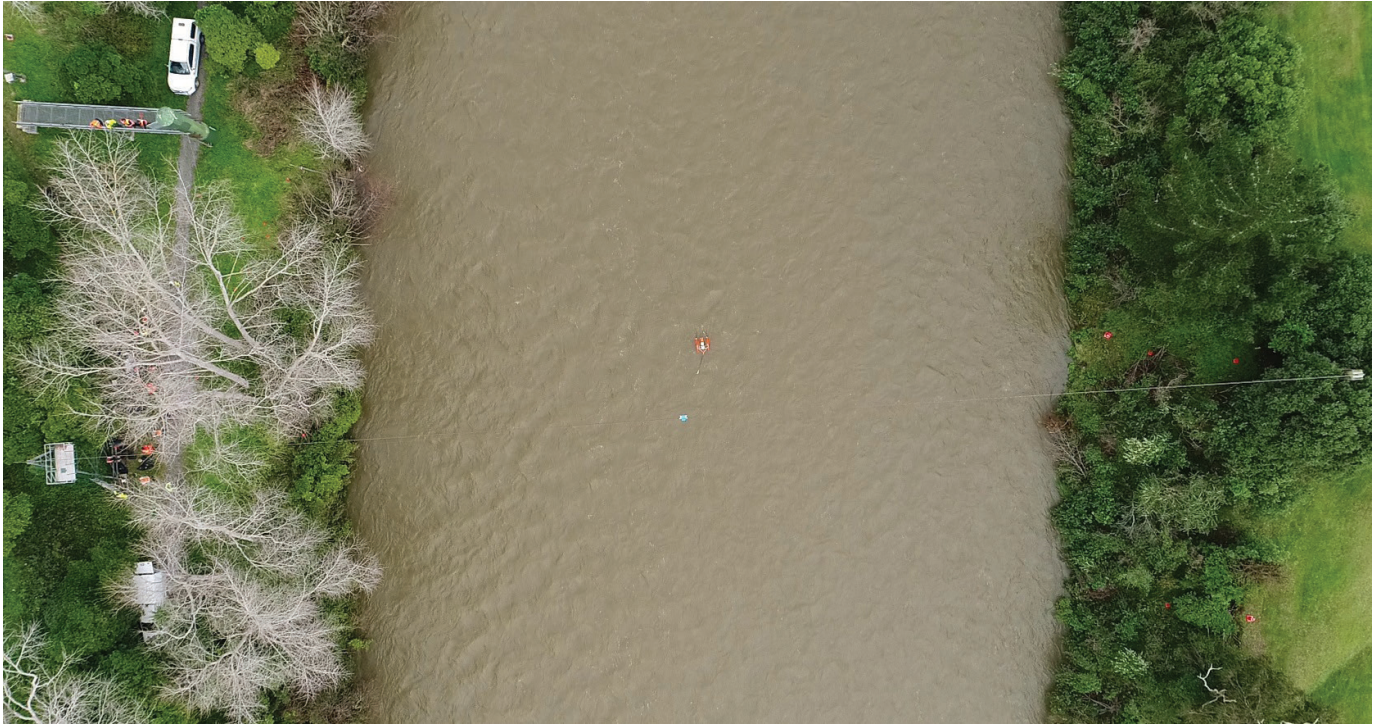
Figure 4: Drone shot of STIV workshop section.

Drone vision collected for post processing into the software was collected with a DJI *Phantom Pro* and DJI *Spark*.

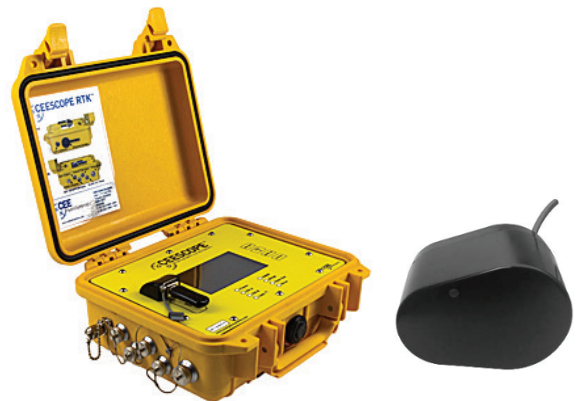
CEESCOPE and M195 Dual Frequency echo sounder from CEE HydroSystems shown in Figure 2 was mounted on an unmanned surface vehicle (USV) for the bathymetric component of the survey. The data was transmitted from the CEESCOPE to land based HYPACK® Hydrographic Survey software using CEE-LINK™ shore radio module.

Figure 2: CEESCOPE & M195 Dual Frequency.

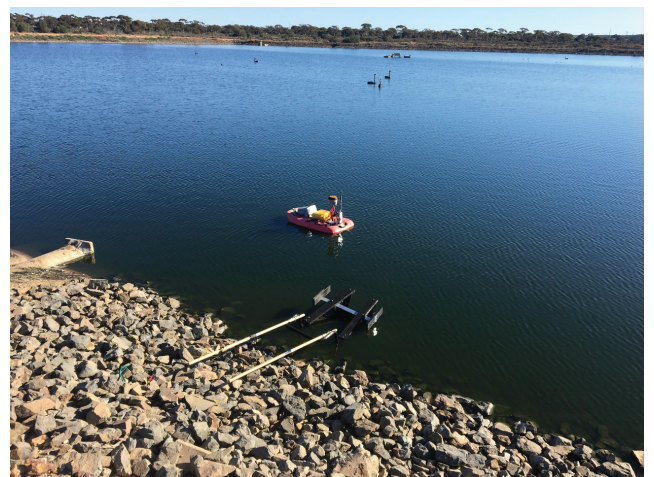
An autonomous rQPOD Modular Remote Survey Boat (Figure 3) was used for the USV. A special mounting was designed for the M195 echo sounder to fit into the existing instrument wet-well.

Figure 3: Autonomous rQPOD.

The line plan developed in HYPACK® Hydrographic Survey software was uploaded onto rQPOD. This enabled rQPOD track the lines autonomously during the bathymetric survey ensuring much higher efficiency in performing the surveys.

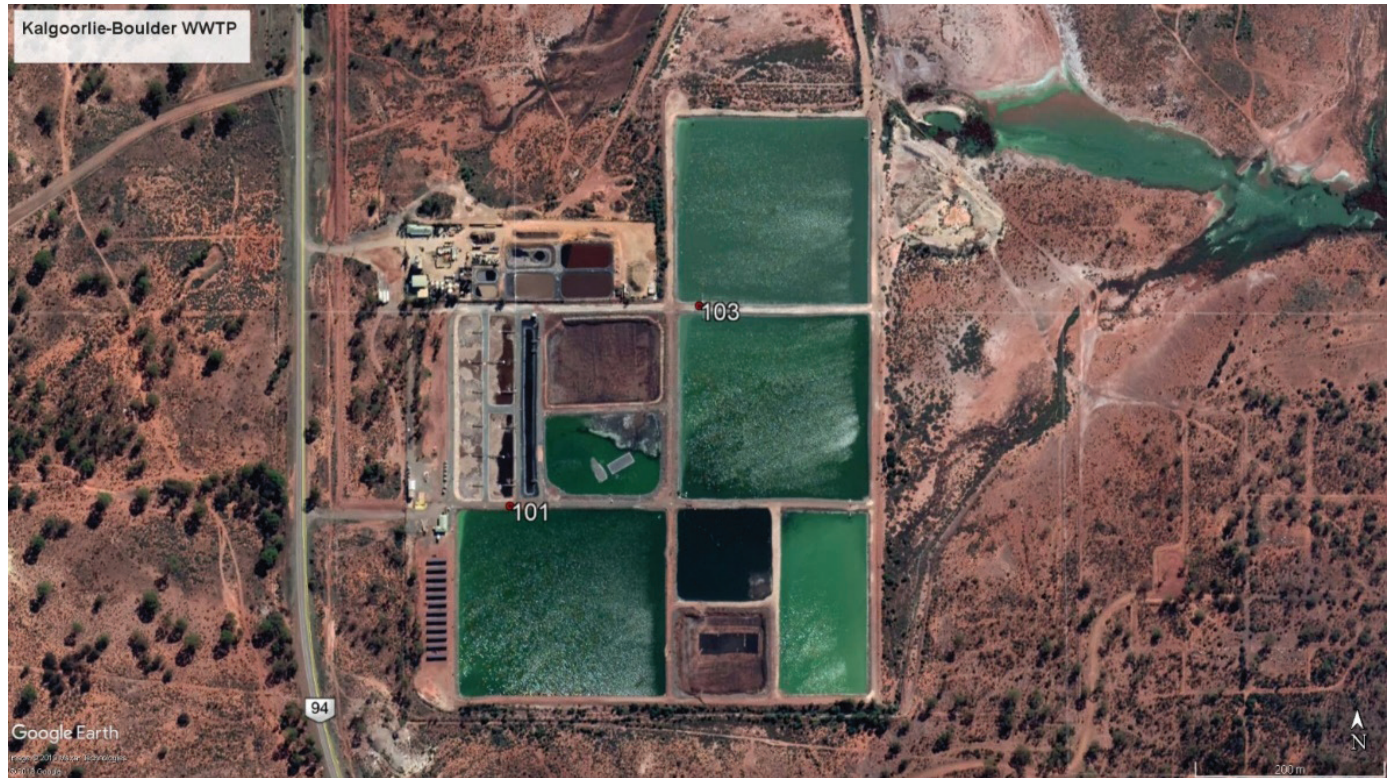
Figure 4: Location of Survey Markers.

The horizontal and vertical survey control for the bathymetry surveys at Kalgoorlie-Boulder WWTP was based on two survey markers, 101 and 103 shown in Figure 4. The position of the survey markers was selected based on requirements for Real Time Kinematic (RTK) survey technique that was used for both topographic and bathymetric surveys.

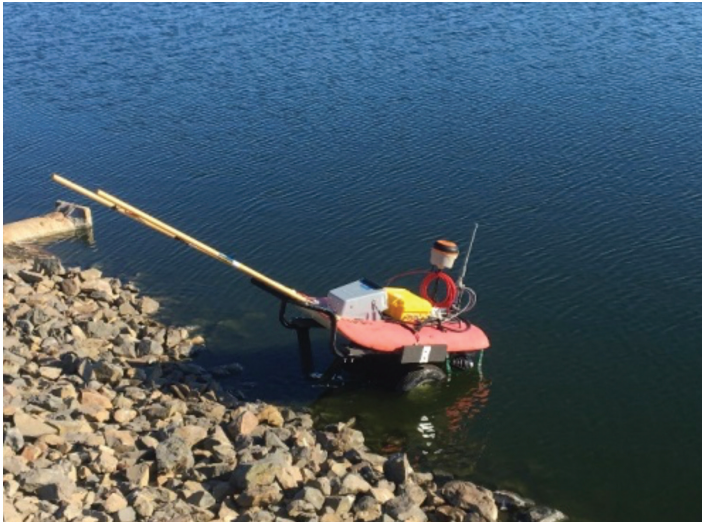
Figure 6: rQPOD Platform.

The bathymetric survey was performed using a CEE HydroSystem with dual echo sounder and HYPACK® Hydrographic Survey software. The survey vessel consisted of rQPOD remote control platform with autonomous feature shown in Figure 6.

The topographic and bathymetric surveys were based on RTK survey technique, using Hemisphere S321 Smart Antennas.

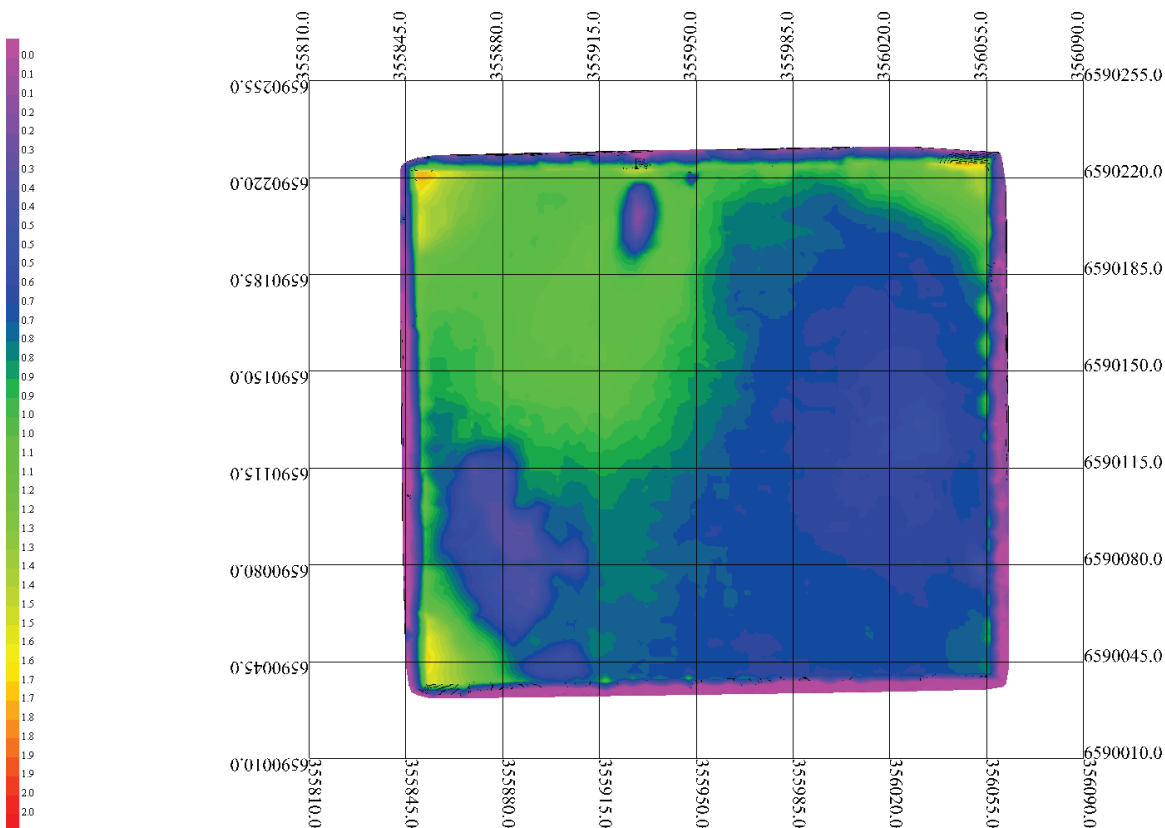
Figure 13: Sludge Thickness at Wastewater Ponding Lagoon 1.

The sludge thickness was determined by developing an elevation model for Sludge Surface and the As-Build drawings of the lagoons. The difference in elevation between sludge surface and as-build elevation models resulted in the total thickness of the sludge at each of the lagoons. The total sludge thickness at Wastewater Ponding Lagoon 1 is depicted in Figure 13.

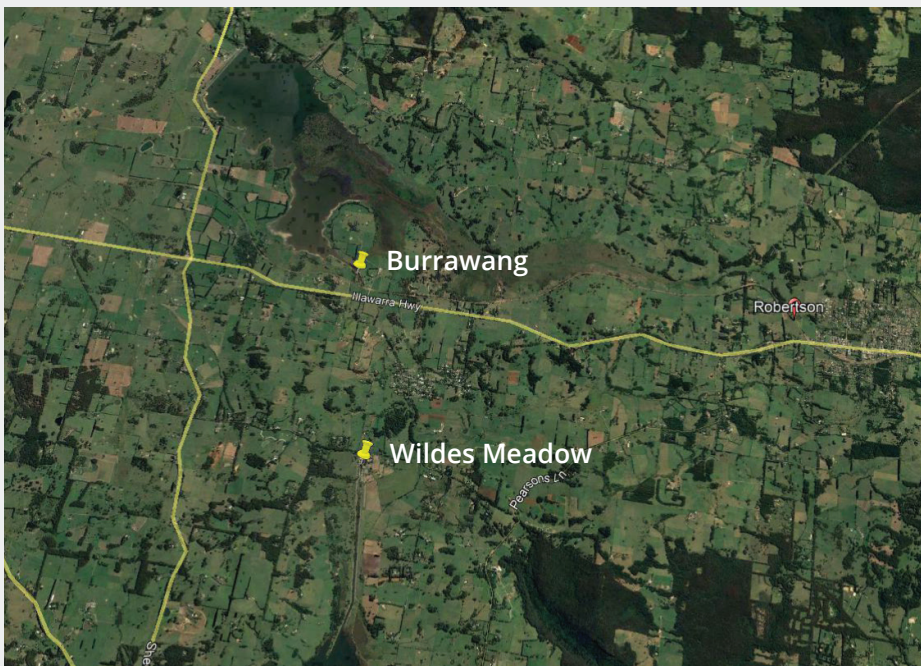
The Wildes Meadow and Burrawang flow monitoring sites are strategically positioned on either side of the Burrawang pump station shown in Figure 1. The strategic positions were selected to accurately measure the abstraction from Fitzroy Falls Reservoir and inflow into the Wingecarribee reservoir during pumping at Burrawang pump station.

Figure 1: Location of Wildes Meadow and Burrawang Flow Monitoring Sites.

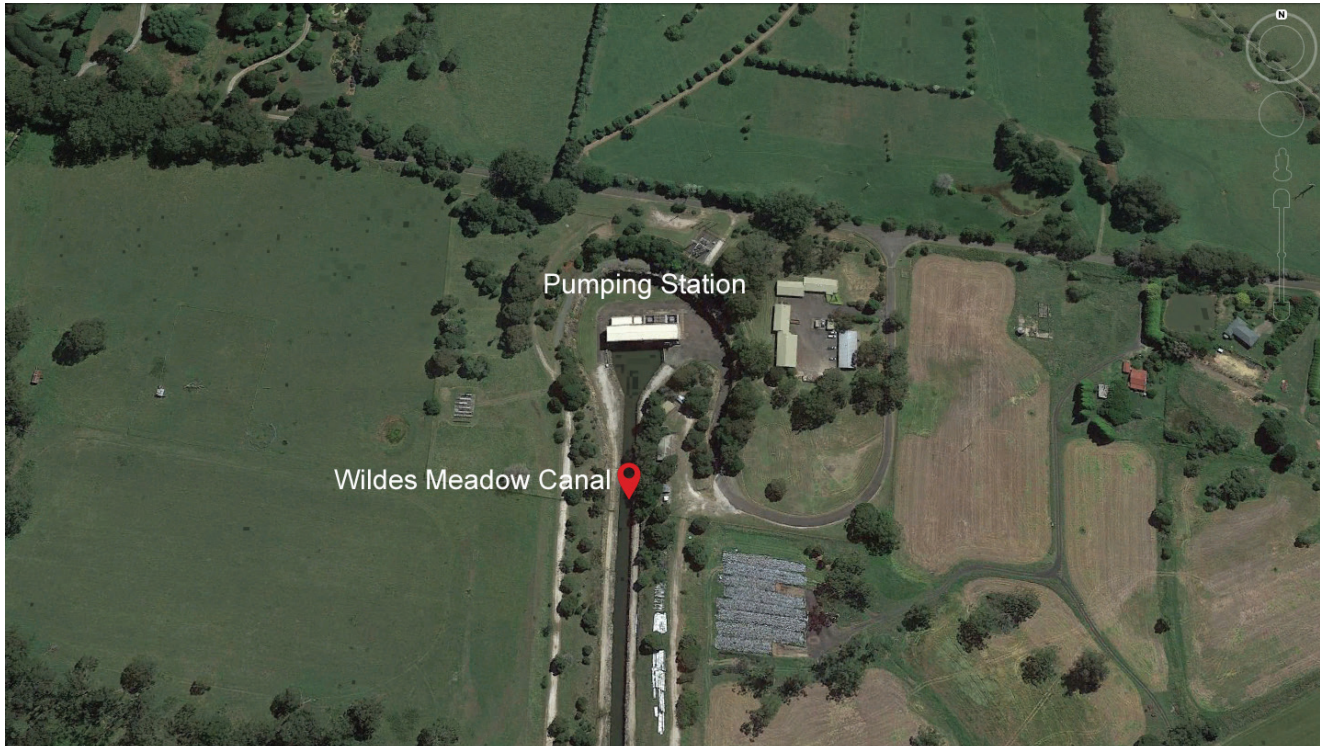
Figure 2: Location of Wildes Meadow Flow Monitoring Site in relation to Burrawang Pumping Station.

The flow monitoring site is located within the Wildes Meadow canal upstream of the extraction end of the Burrawang pumping station. The Wildes Meadow canal is classified as an earth canal, excavated in solid granite rock.

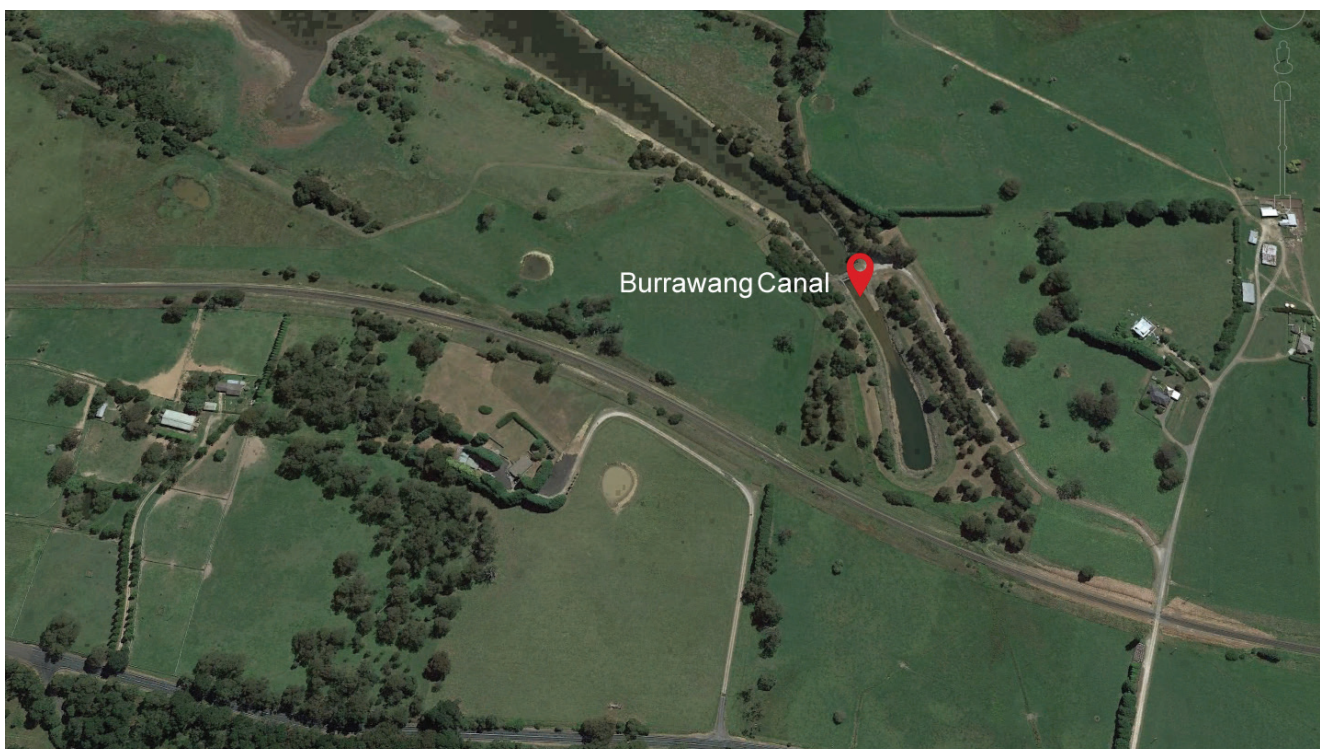
Figure 3: Location of Burrawang Flow Monitoring Site in relation to Radial Gate Hydraulic Structure.

The flow monitoring site is located within the Burrawang Canal directly upstream of the radial gate but within the flank walls on the delivery end of the Burrawang pumping station.

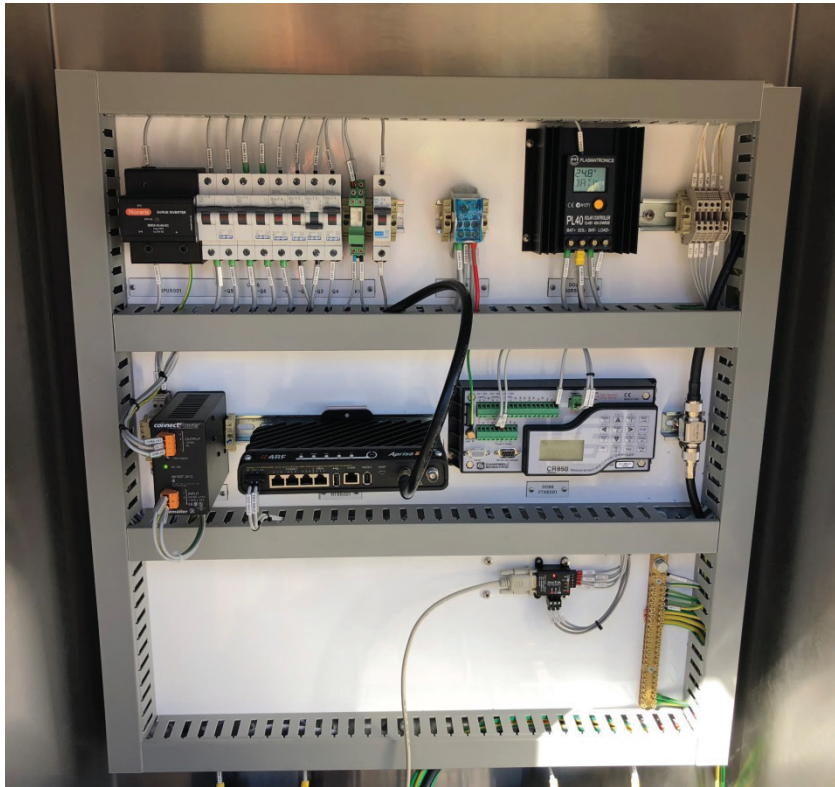
Figure 4: Station backing panel consisting of SCADA RTU, data logger, and solar system.

- SonTek SL1500-3G
- Retractable instrument slide
- SL1500 communications cable
- Campbell Scientific CR850
- Local power enclosure and platform

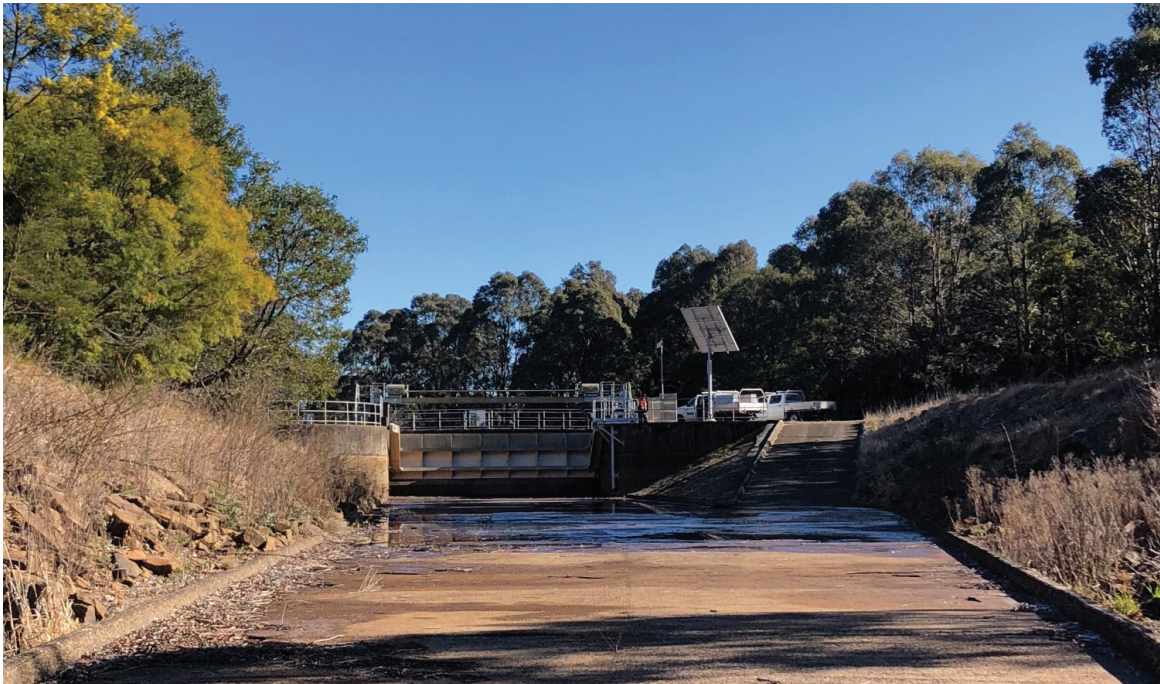
The SL cross section is located between the Wingecarribee radial gate spillway and rounded approaches of the radial gates flank walls.

Figure 5: Upstream, looking downstream towards radial gate.

The nominated measurement section for the SL was not ideal, due to the nature of the measurement site and the hydraulic conditions present, impacting both the velocity measurements and overall operation. The proximity of the radial gates, in relation to the SL is the biggest concern, placing the SL measurement volume within the spillway's drawdown zone, as well as being influenced by the resulting higher approach velocities through the section.

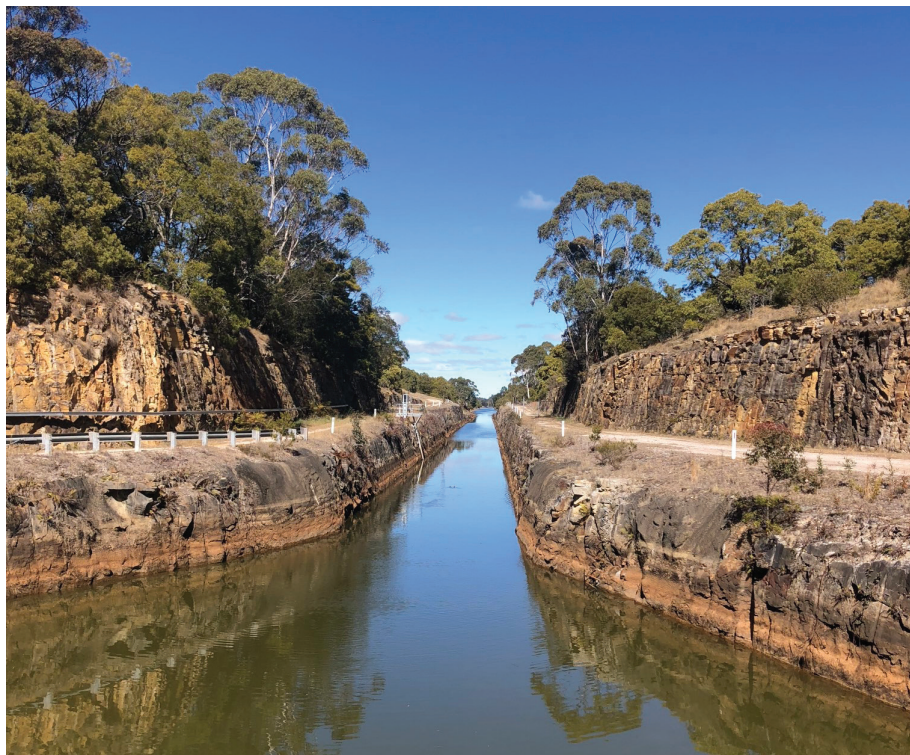
The Wildes Meadow canal excavated in solid granite rock is classified as trapezoidal channel with steep slopes. The channel depth of 6.3 m versus width of 8.2 m recorded during measurements results in small aspect ratio.

Figure 9: Downstream of the SL, looking upstream towards measurement section.

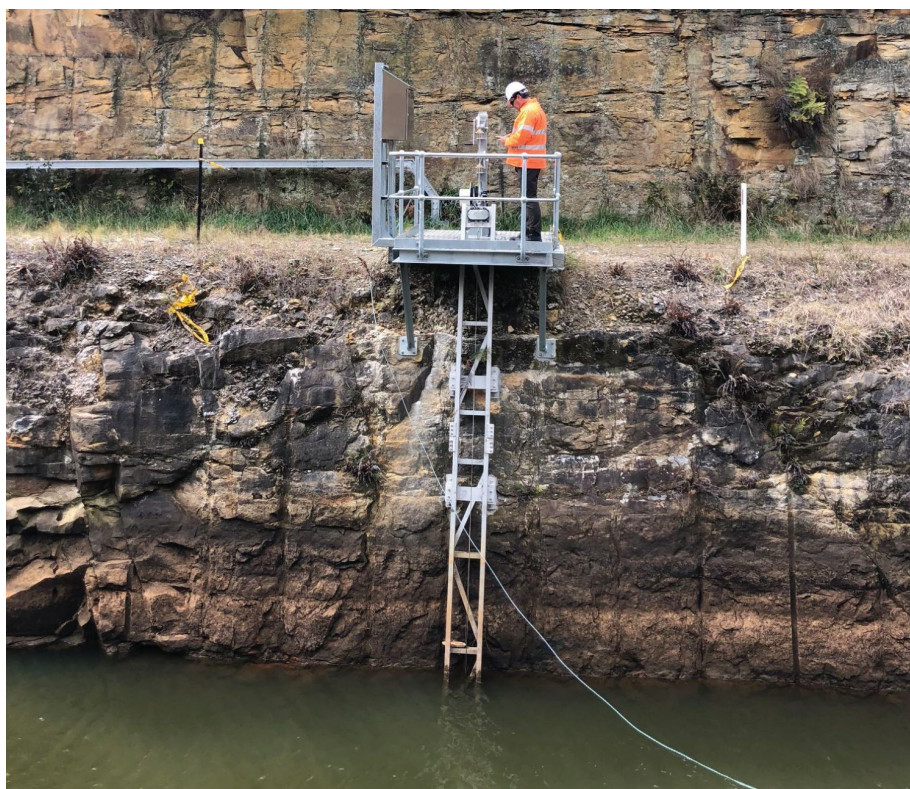
Figure 10: SL Measurement Section.

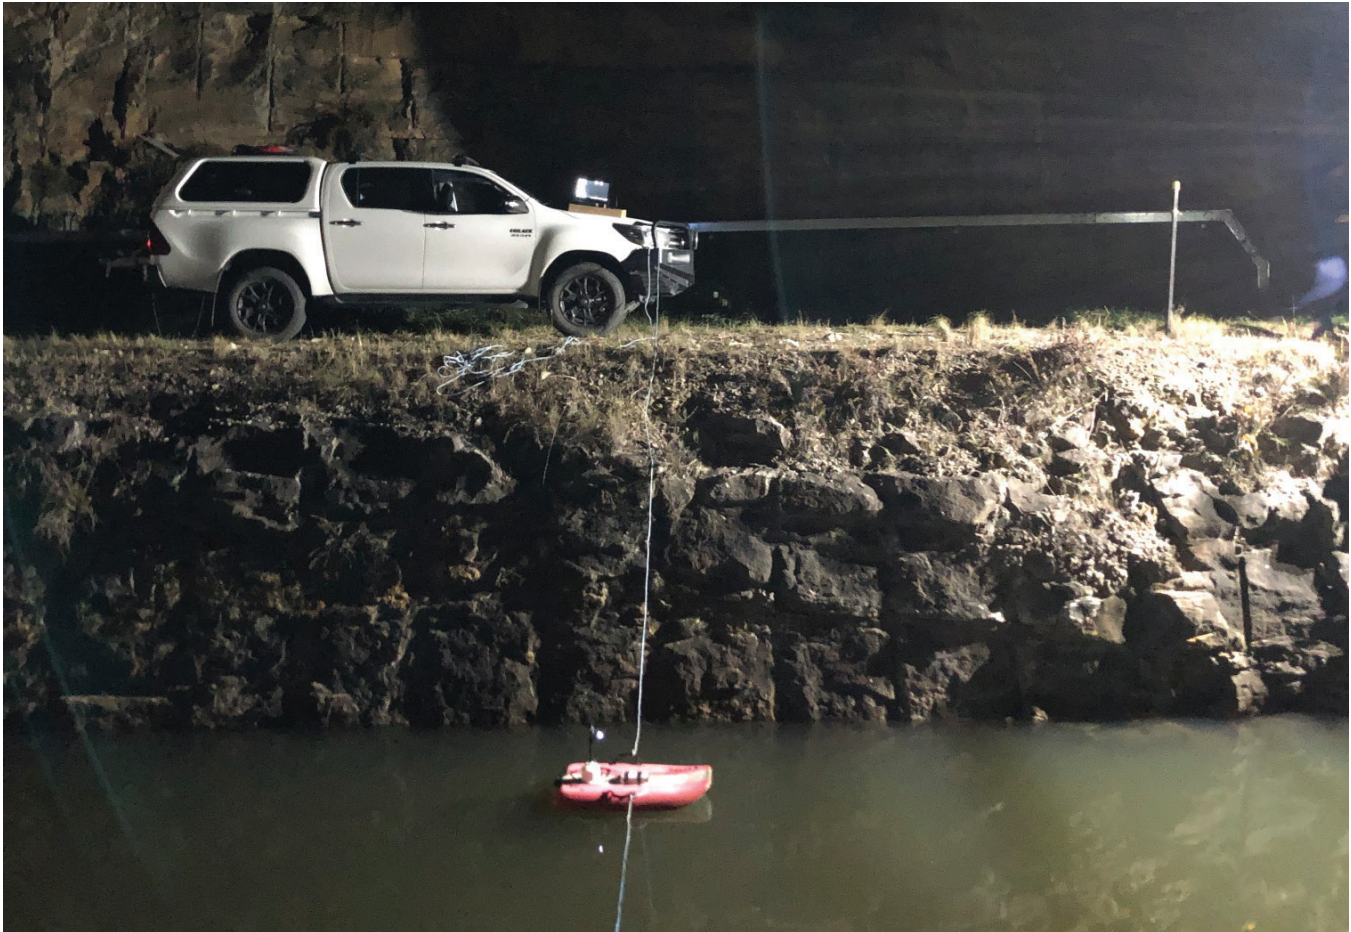
Figure 14: Equipment setup in preparation for pump run measurement.

Prior to any calibration gaugings being undertaken, several pump tests were carried out. It was found during these that both SL units measured approximately 5-10% differently from expected pump flow rates at both locations. Two operational states exist where either one pump is active, or both pumps are active making for a relatively straight forward indexing.

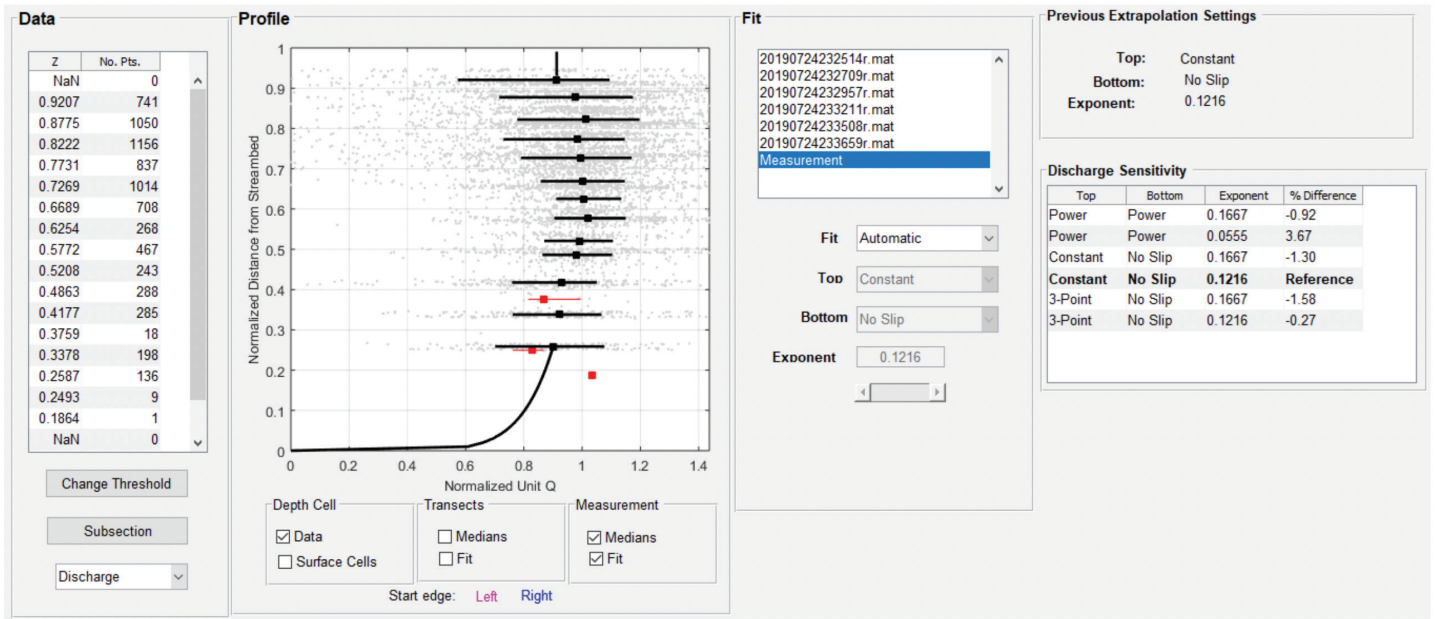
Figure 18: Wildes Meadow Double Pump run.

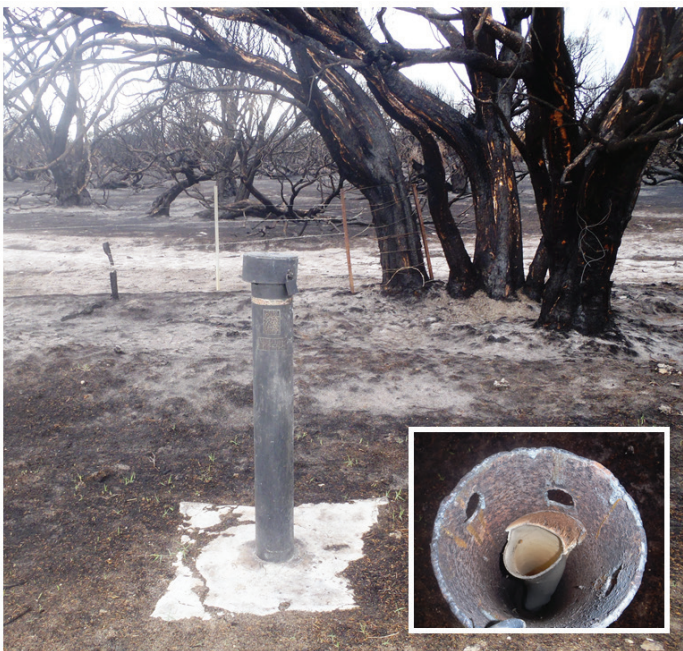
Figure 5: Bore HS24A, Damage to surrounds and inner casing post Waroona Fire.

*"We (DWER) had a total of 7 groundwater monitoring bores damaged to the point of requiring headwork replacements. None required redrilling. Several other bores sustained superficial damage, which only required repainting of the headworks. The bores are monitored on a maximum/minimum frequency (Mar, Apr, May and Sep, Oct, Nov) and repairs were made before monitoring commenced so fortunately no data was lost.*

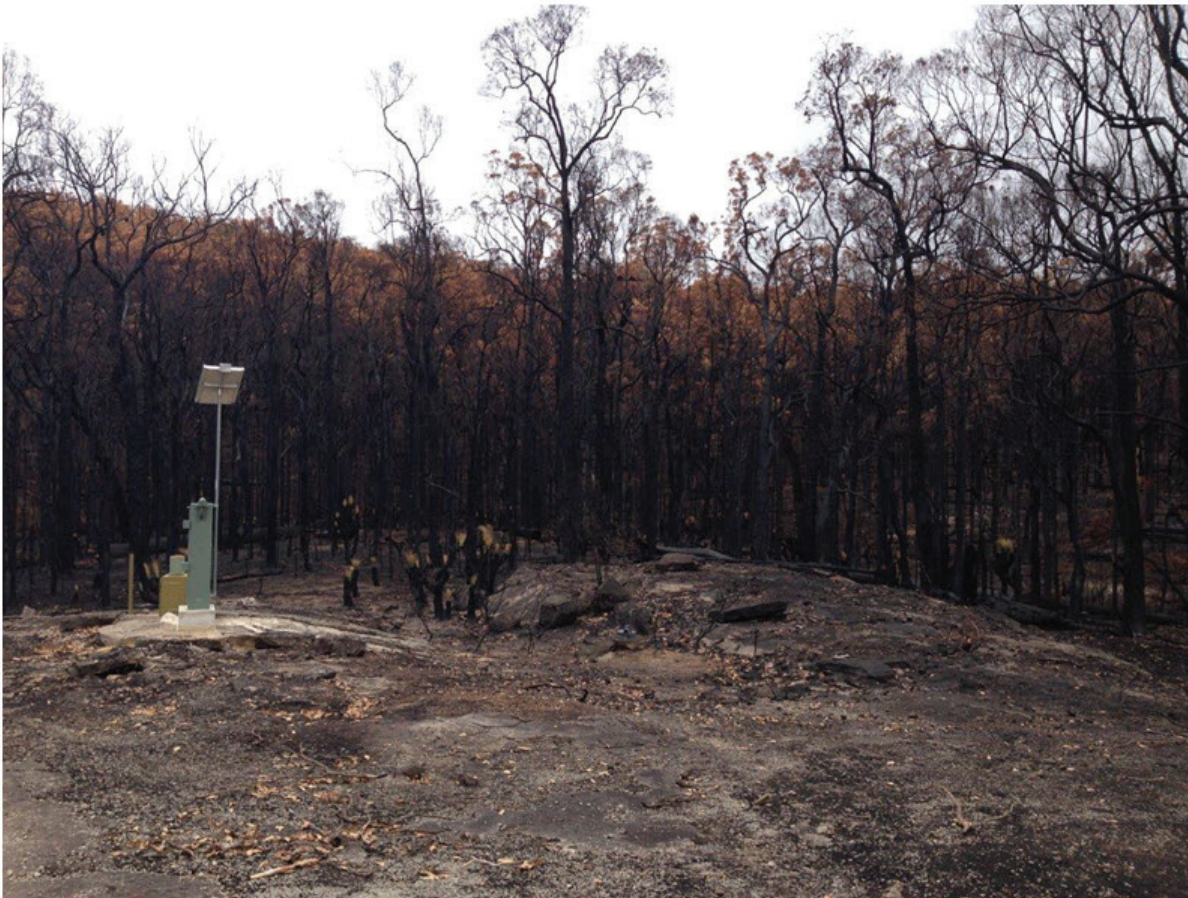
Figure 6: Samson Brook below Main Dam — DWER Rainfall Site post fire.

Fortunately the impact of the Waroona fire on DWER's monitoring network was minor. The overall estimated cost to repair and resurvey within \$10,000.

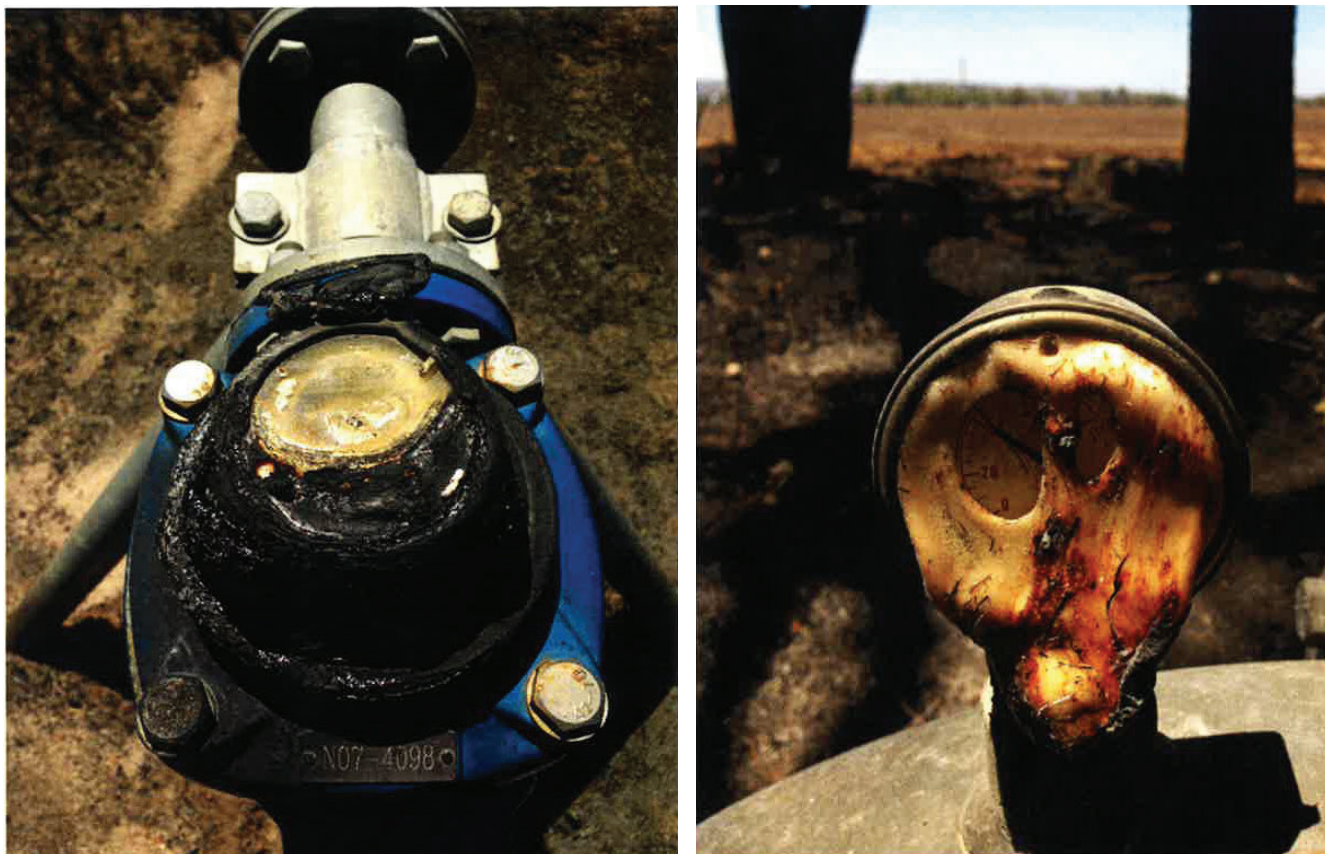
Figure 7: Example of Harvey Water Hydrometric Assets damaged by the Waroona Fire. Left: Mechanical Meter, Right: Pressure Gauge.

*"The impact of the Waroona fire on Harvey Water's monitoring network was primarily in the form of damage to electronic and mechanical meters, pressure gauges and data loggers installed within the Waroona and Harvey Irrigation Districts. The estimated cost to repair these assets in the order of \$30,000" (Kate Duzevich pers. comment, June 2018).*
