# Australasian Hydrographer September 2019

AUSTRALIAN  
HYDROGRAPHERS  
ASSOCIATION

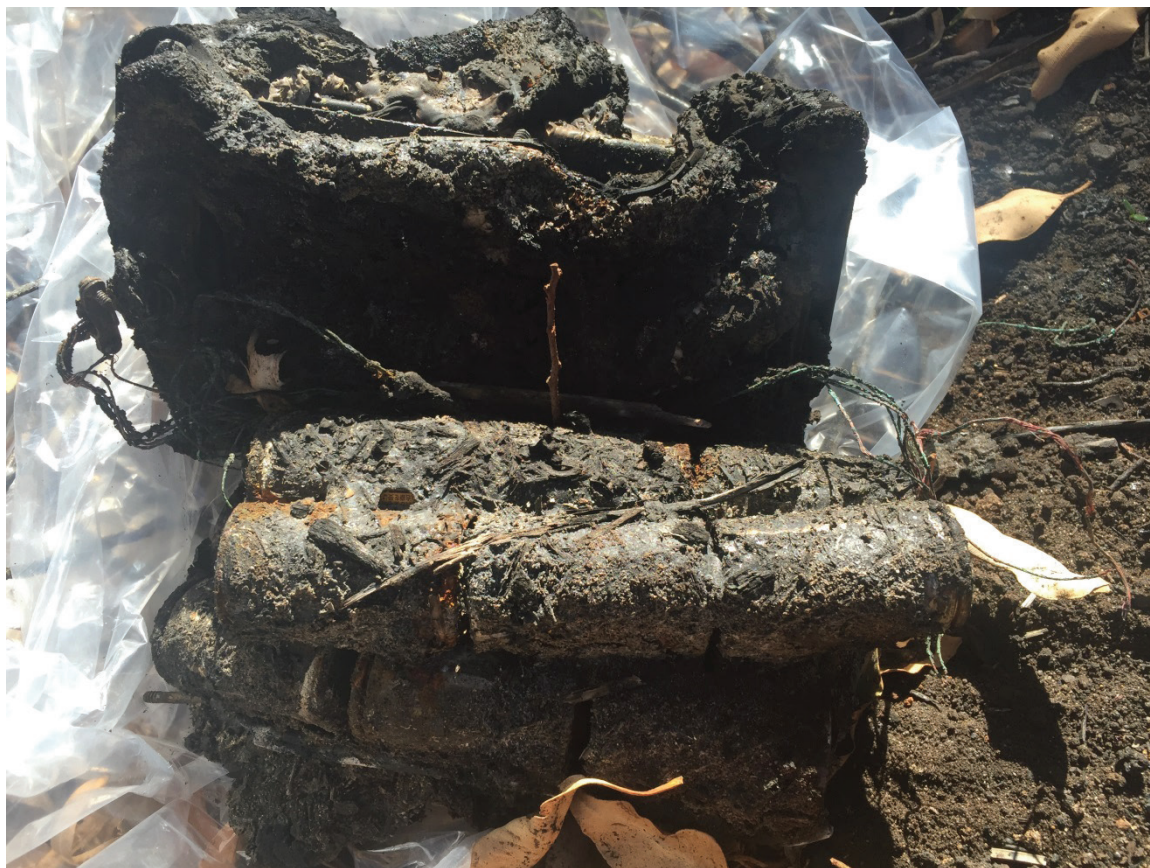
Figure 8: Damaged Logger from 6215W001 — Samson Brook at 1st Below Pipehead.

Overall the damage to the corporation's hydrometric network from the fire and post fire events was limited to \$40,000. The primary damage was to six gauging stations installed in series along the Samson Brook reach. The sites were commissioned in 2014 for the *Samson Brook Environmental Water Provisions* Research Project.

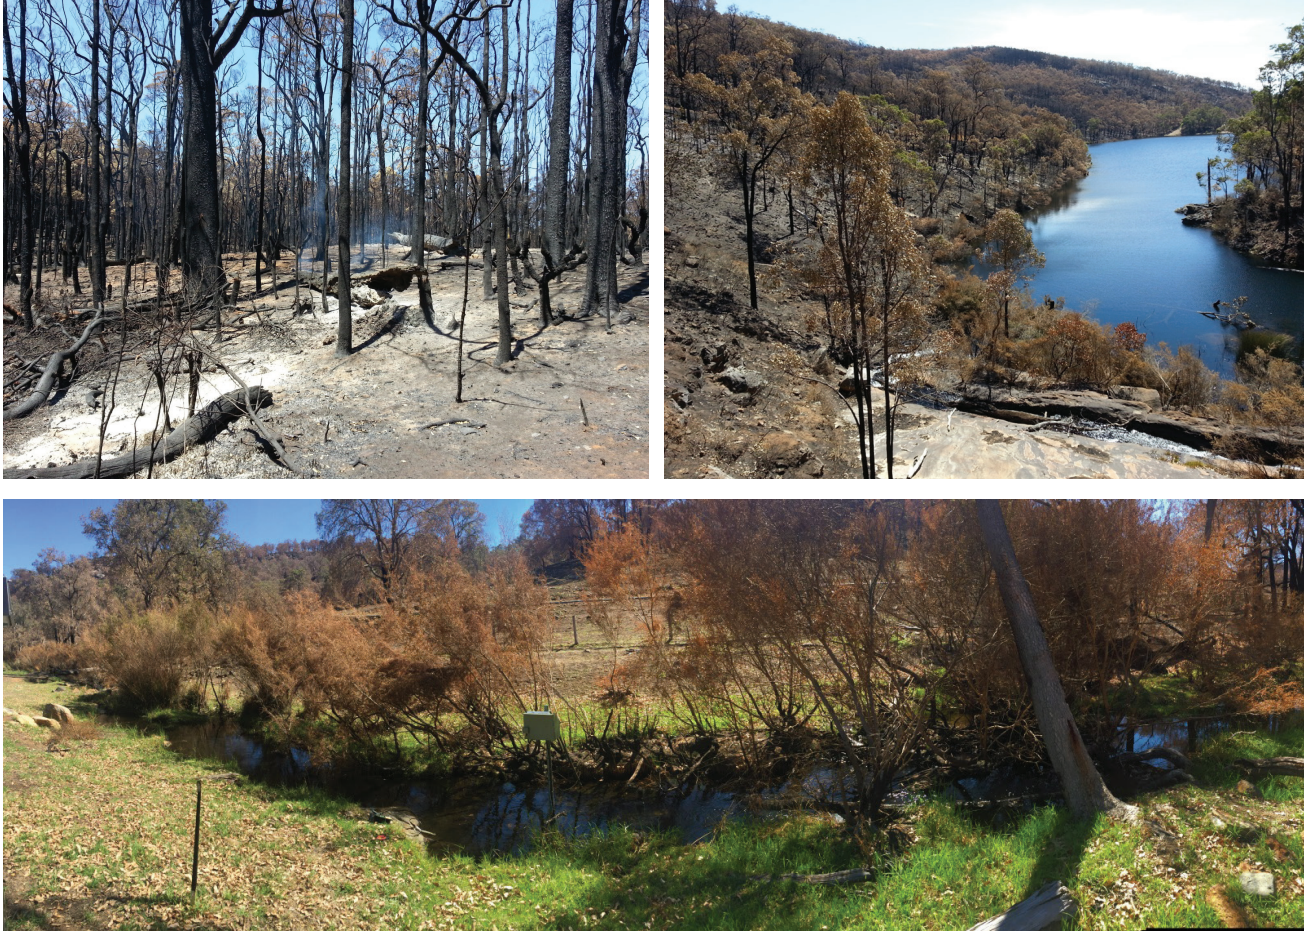
Across the Upper Samson Brook Catchment the fire was extremely intense, completely removing all littoral and vegetation cover. However between the main dam and the Samson Pipehead the intensity of the fire resembled that of a prescription burn leaving leaves on the tops of trees and some leaf litter on the ground (Figure 11).

Figure 11: View of typical damage to catchment. Left: Upper Samson Brook Catchment, Right: View to Samson Pipehead Dam Wall (Images by M. Sturges, Aroona 2016), Bottom: Samson Brook at Paddock East

Below the Samson Pipehead dam the effect of the fire on the remaining forests also resembled a prescription burn whilst within the lower pastoral land; the impact was limited to the riparian zones (see to Figure 11).

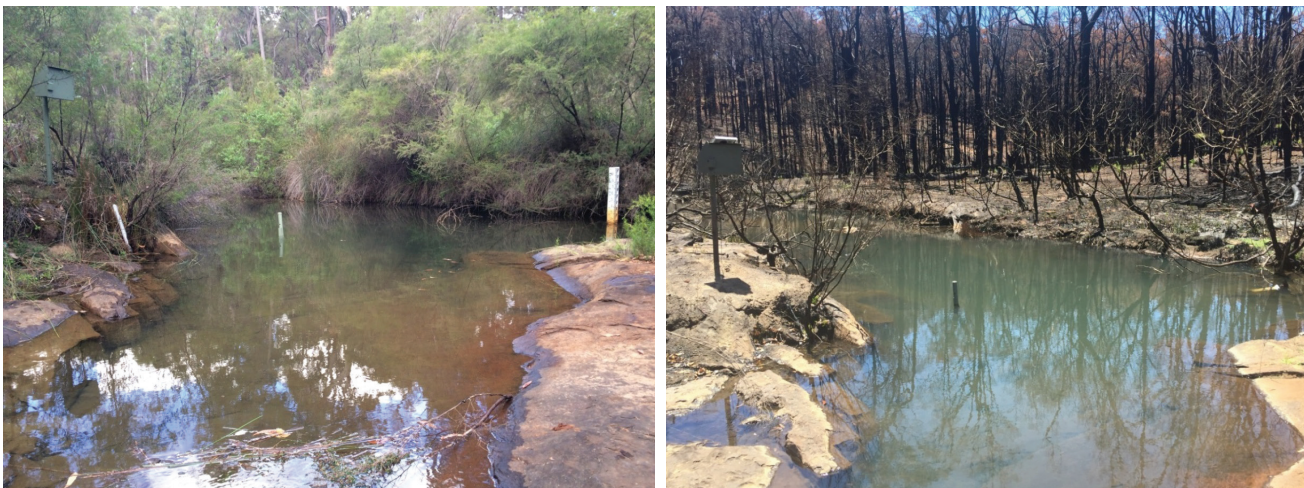
Figure 12: Below Main Dam W8000969. Left: Prior to the Waroona Fire March 2015, Right: Post Fire February 2016.

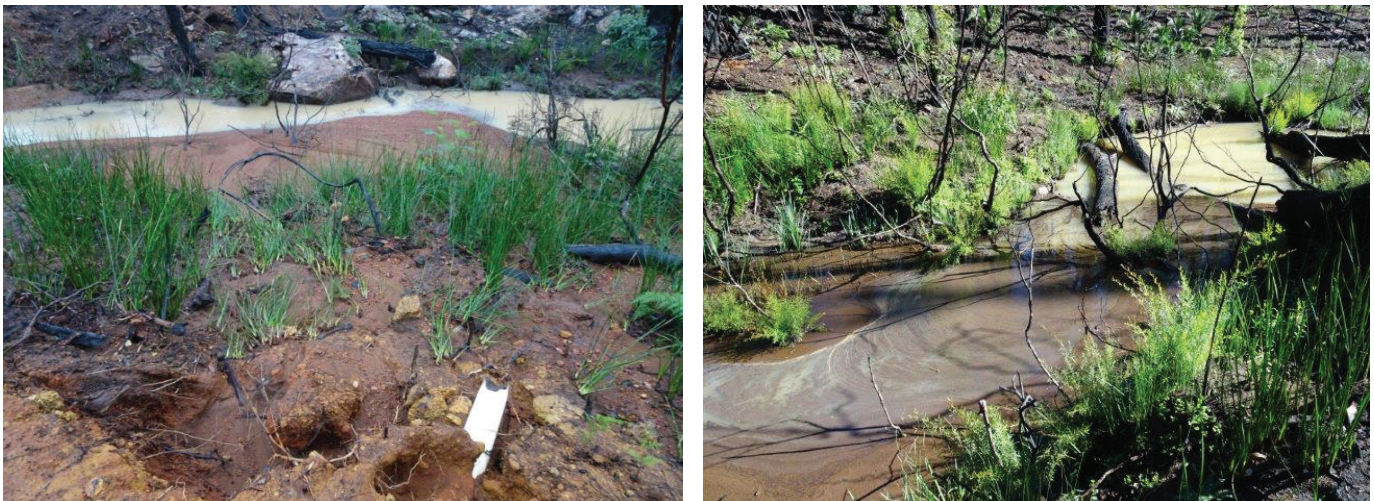
Figure 13: Samson Dam to Pipehead Creek Line. Left: Bank erosion, Right: Suspended sediments in the brook, post rainfall event May 2016 (Images by M. Sturges, Arrona 2016).

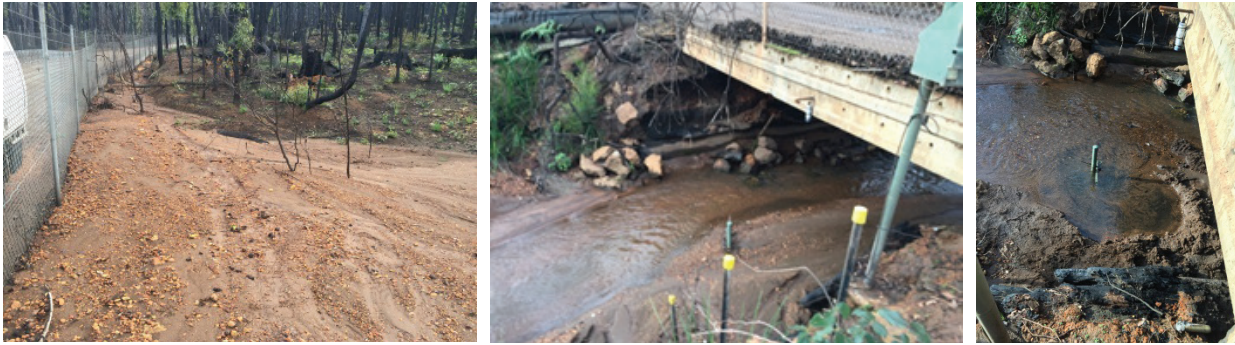
Figure 14: June 2016 (4 months after the fire) 6215W000 Samson Brook at Scarp Rd. Top Left: Hillslope Erosion, Centre: Sediment Build up in the channel, Right: Excavated pool around DO Sensor.

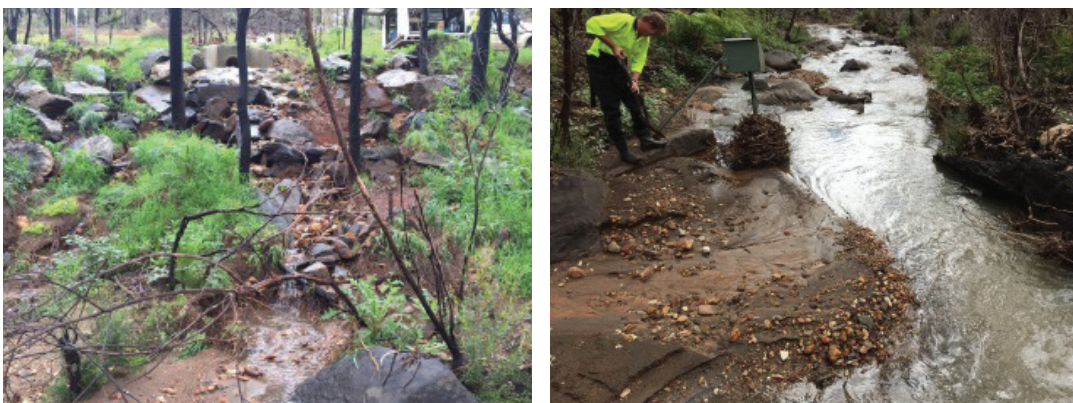
Figure 15: Erosion, Sediment, Debris and Turbid Water at 6215W001 Samson First Below Pipehead June 2016 (4 months after the fire).

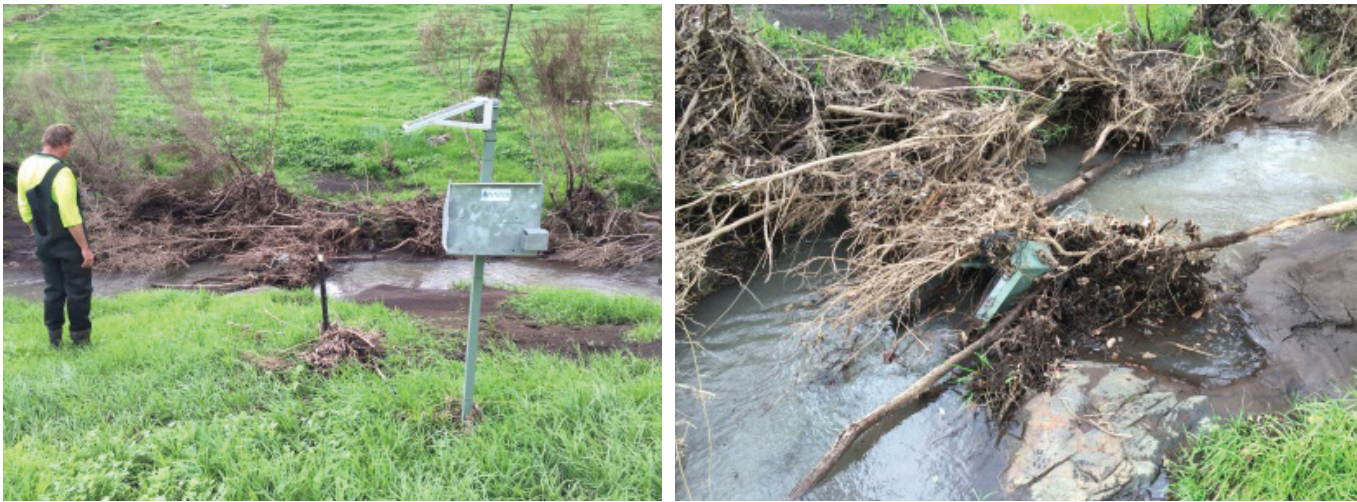
Figure 16: Damage to 6215W002 Samson Brook at Paddock East June 2016 (4 months after the fire).

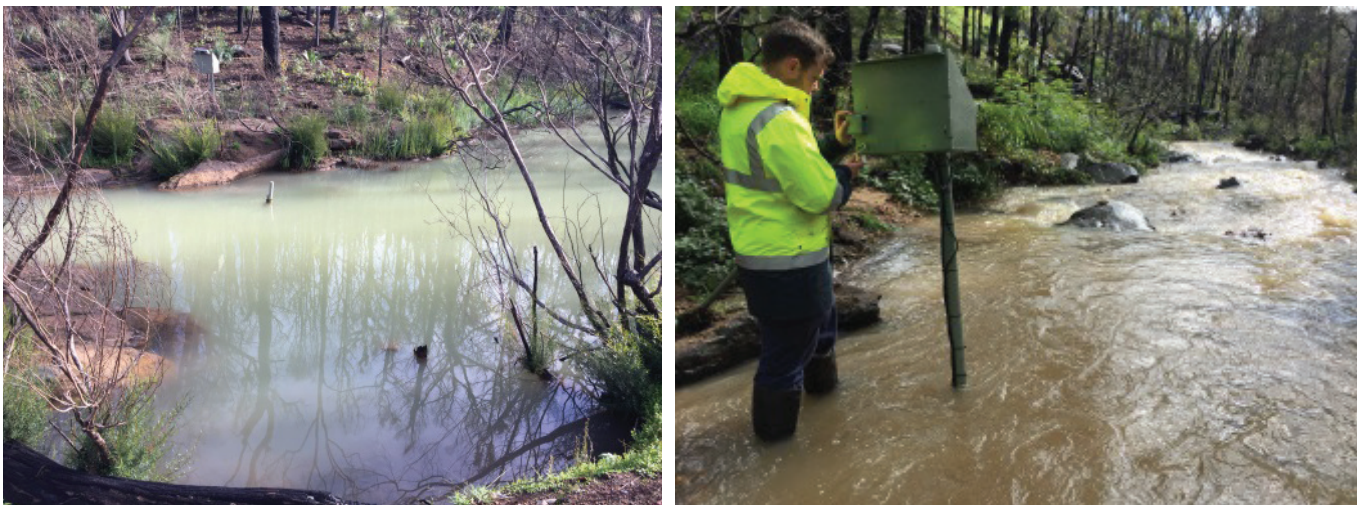
At all six sites the water flowing through the Brook continued to have high levels of turbidity.

Figure 17: Turbid Water at Left: W8000969 Samson Brook at Below Main Dam, Right: 6251W001 Samson Brook First Below Pipehead August 2016 (8 months after the fire).

Because turbidity has historically been shown to have a strong influence on Dissolved Oxygen levels, the project team commissioned the installation of continuous turbidity meters at select sites for the remainder of the project.

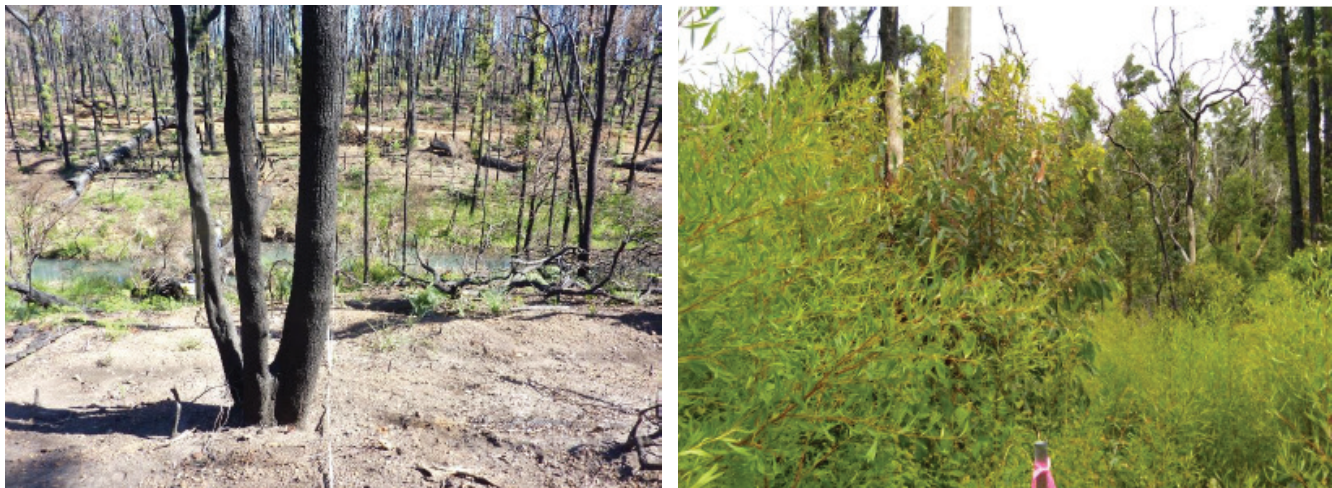
Figure 18: Samson Brook Riparian Vegetation Transect. Top: Autumn 2016 (~ 2 months after the fire), Bottom: Summer 2018 (2 years after the fire) (Mattsike, 2018).

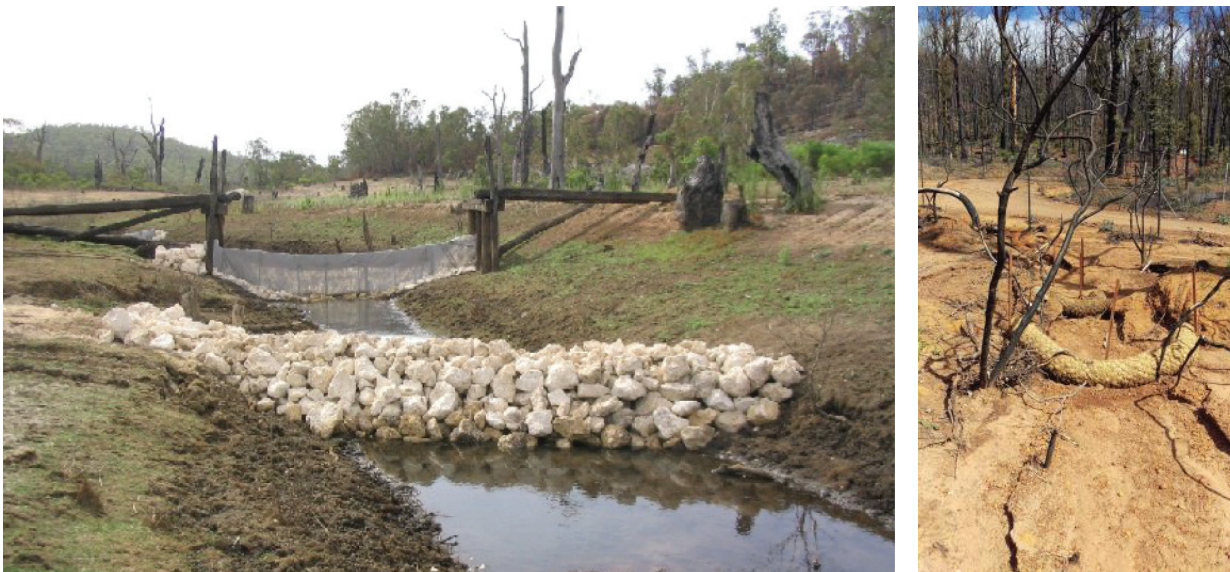
Figure 21: Left: limestone and geofabric sedimentation structures installed in Mundaring Catchment post 2005 Hills fire, Right: Coir Logs installed near 6215W000 Samson Brook at Scarp Rd.

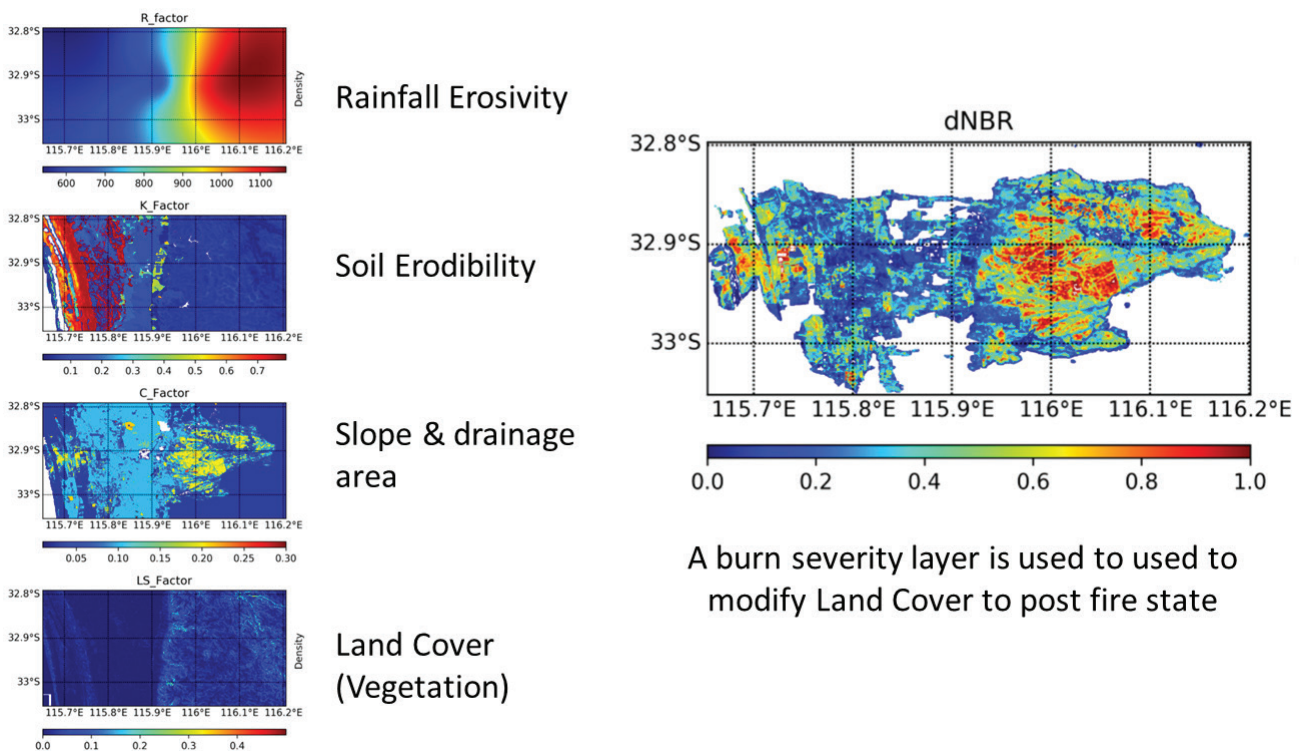
A burn severity layer is used to used to modify Land Cover to post fire state

Figure 22: Inputs into a fire response model.
