# Australasian Hydrographer September 2019

# Contents

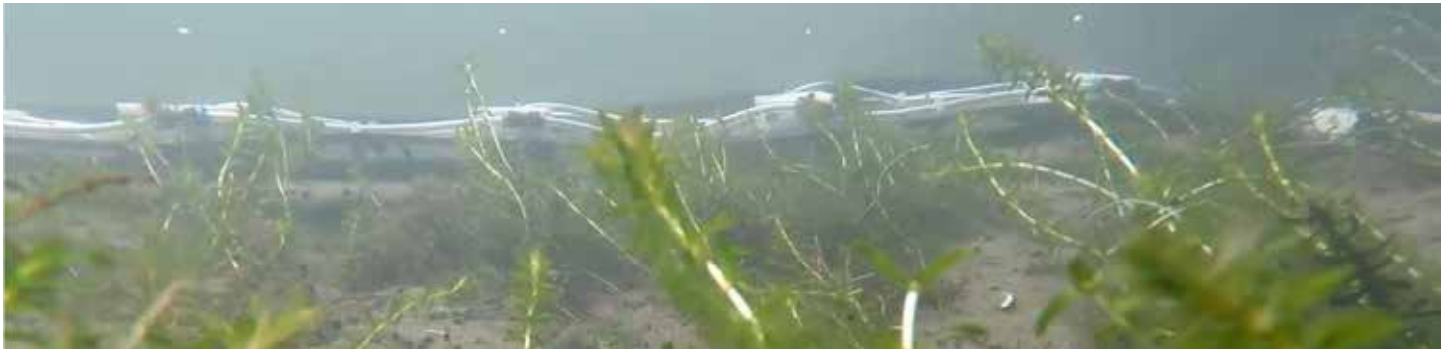
Figure 2: Underwater view showing each injector simultaneously releasing a single bubble.

60 frames per second). A single bubble was injected simultaneously from each of the 20 injectors to release a line of bubbles at the streambed across the width of the stream. This was repeated nine more times (every 1.7 seconds). Each of the 10 snapshots gave an instantaneous value for Q.

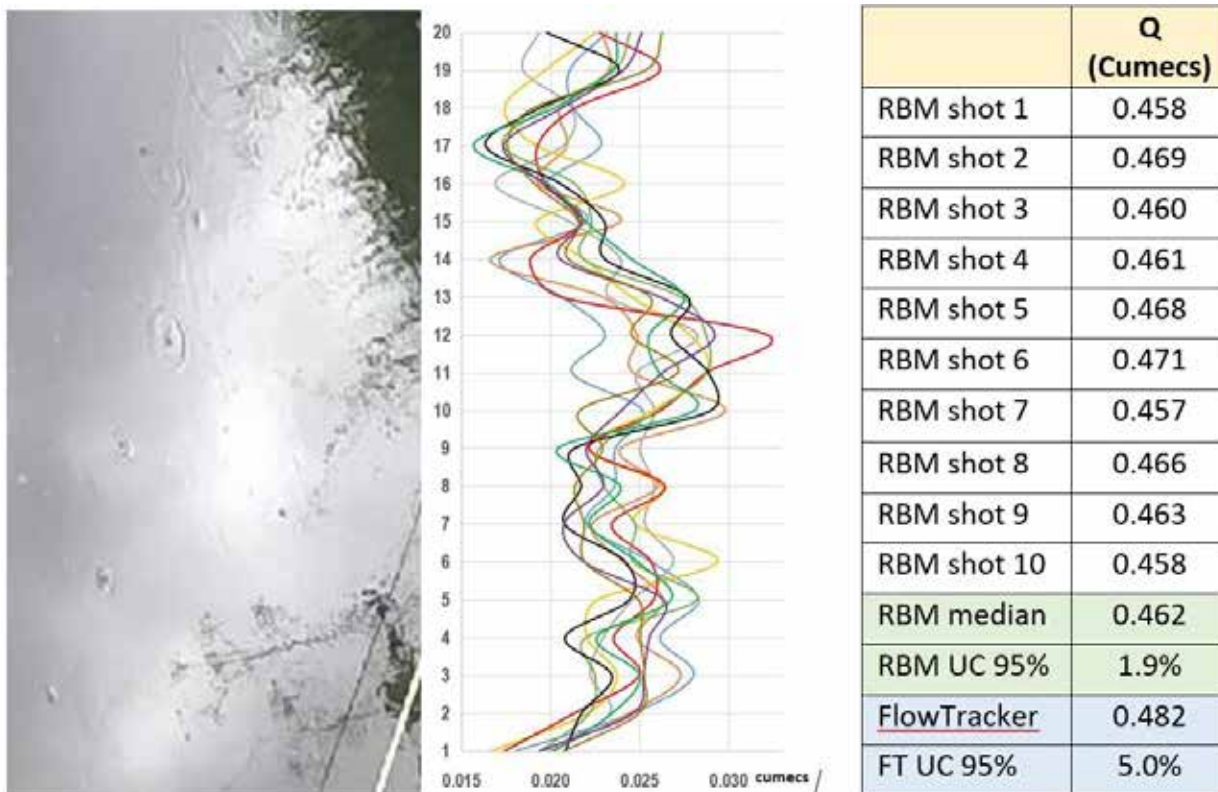
Figure 3: Left - bubbles surfacing. Middle - colour-coded chart depicts the partial discharge that each of the 20 injectors contributed to Q showing how the flow rate (not the velocity) varied across the stream width. Right - results from 10 'flow-shots', producing 10 near-instantaneous snapshots of Q.

Less than a second elapsed between the earliest and latest bubbles to 'just surface' within each sequence with the difference depending on the depth. The mean depth was 0.6 m. Our reference was a Sontek FlowTracker, sampling at 20, 60 and 80% of depth every 0.2 m.

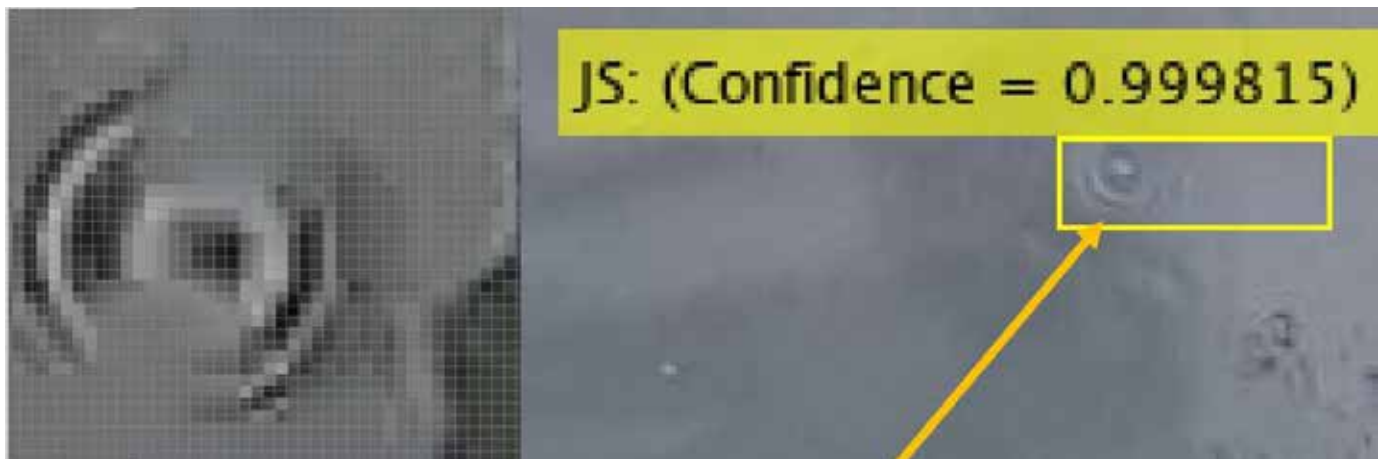
Figure 7: The Artificially Intelligent trained network detects a 'just-surfaced' bubble at the pixel limit of resolution.

However, the "Holy Grail" is **full-automation**, using Artificial Intelligence (AI) to detect the definitive 'just surfacing' bubbles and calculating their true downstream displacements. An AI network has been developed and is being trained with bubble images. Detection is working well when the images have sufficient resolution. Therein lies the challenge — obtaining this resolution, while getting 'full-stream-width' within the camera's field of view, is the present limiting factor, and therefore our next focus.

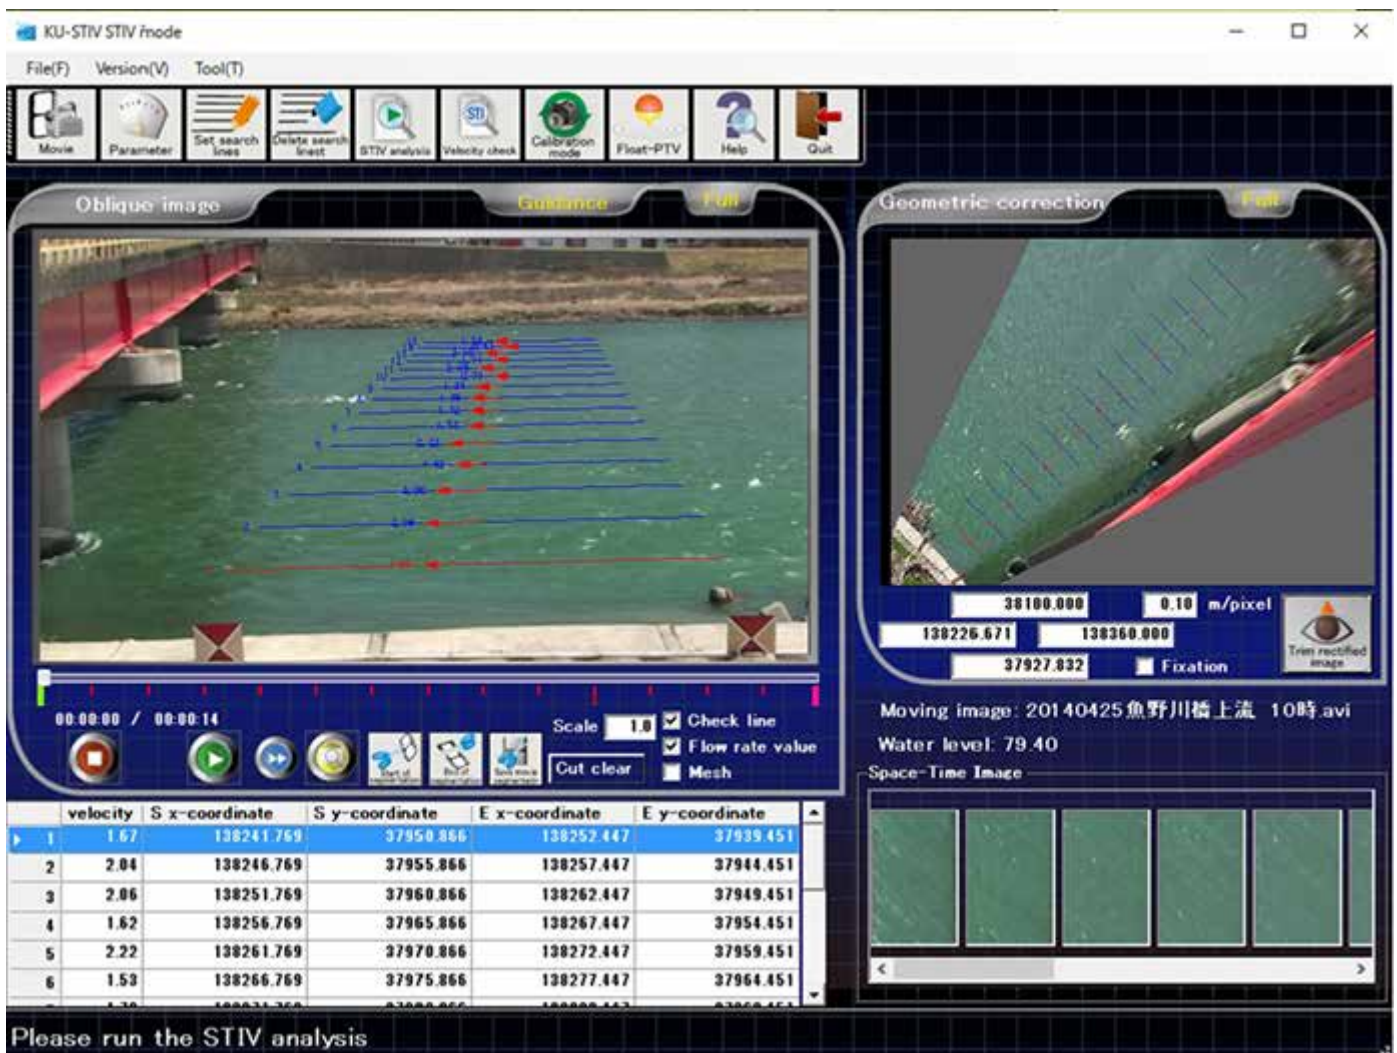
Figure 1: A screen shot from KU-STIV software.

- Orthorectification of the video imagery (removing the effect of perspective and creating a 2D image area for analysis);
- Superimpose “searching lines” (each between 10 and 20 metres long) on footage of the river as measurement standards;
- Calculates the water’s surface speed from the time it takes water surface features and floating matter on the surface of the river to move through these lines;
- Analyse velocity distribution, with suitable ‘alpha’ co-efficients, to indirectly calculate the river flow rate.

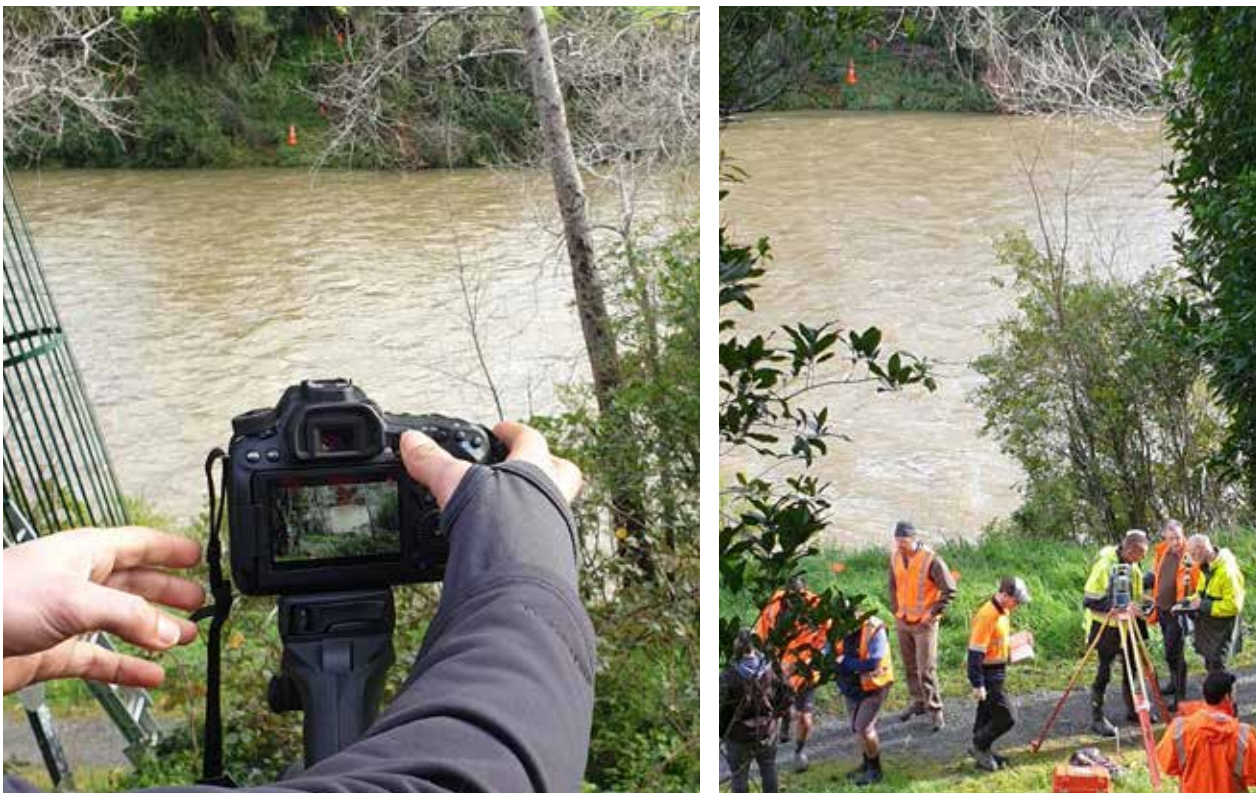
Figure 3: Left, “Fixed” camera installation setup. Right, Total Station survey of ground control points.

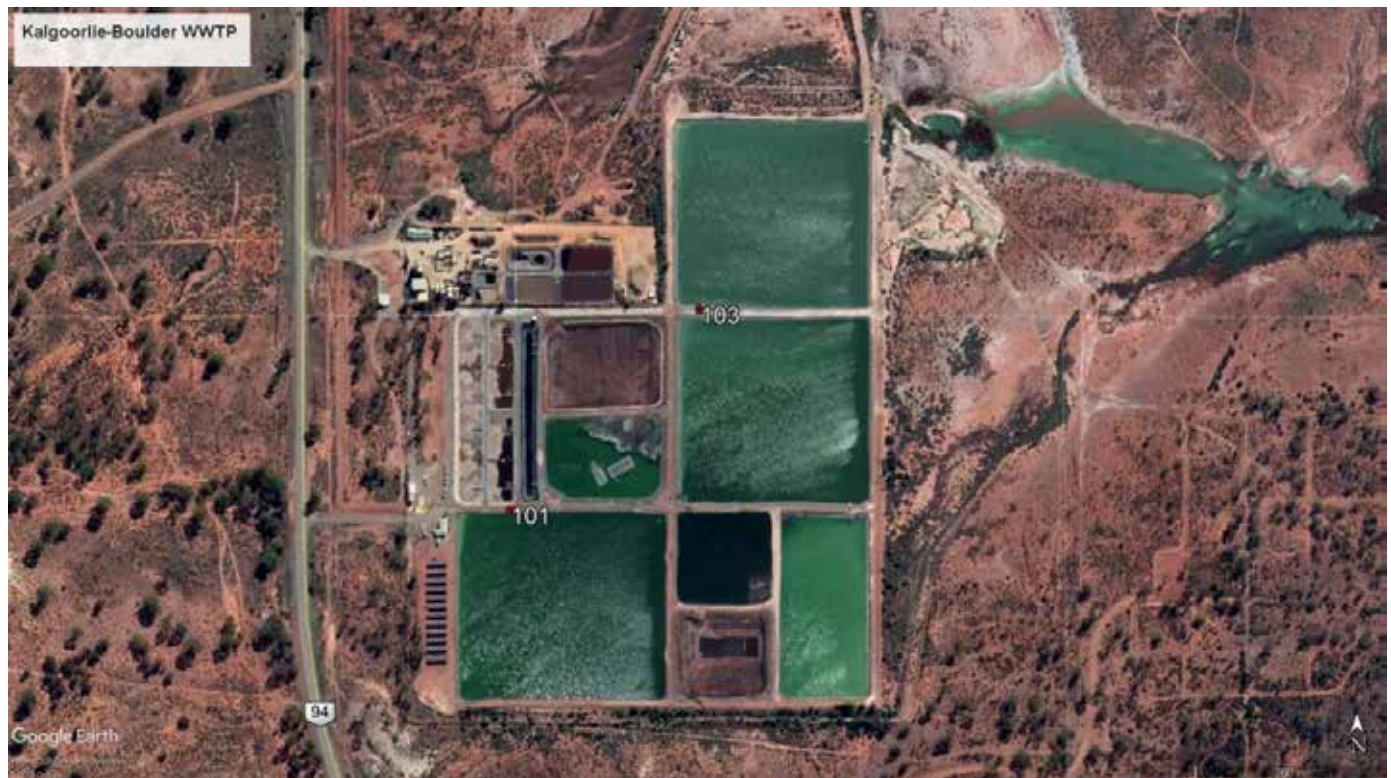
Figure 4: Location of Survey Markers.

The horizontal and vertical survey control for the bathymetry surveys at Kalgoorlie-Boulder WWTP was based on two survey markers, 101 and 103 shown in Figure 4. The position of the survey markers was selected based on requirements for Real Time Kinematic (RTK) survey technique that was used for both topographic and bathymetric surveys.

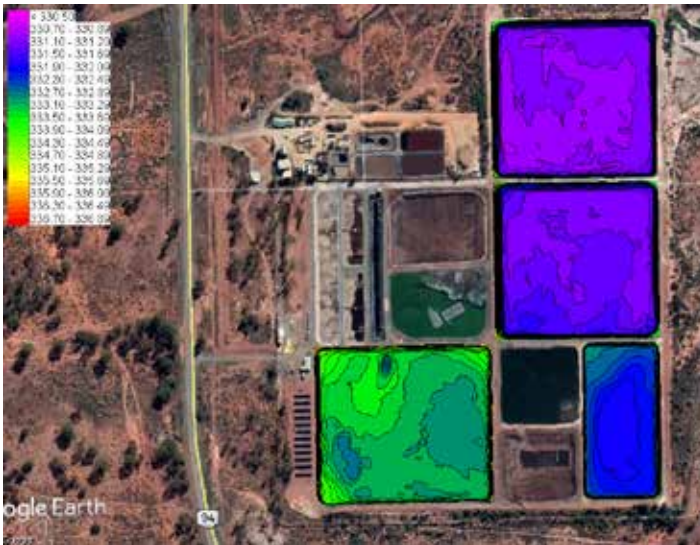
Figure 8: Sludge Surface Elevation.

An elevation colour scheme range of 330.50 – 337.00 m AHD was adopted for all four lagoons. This clearly shows the difference in elevation of the sludge surfaces between the four lagoons.

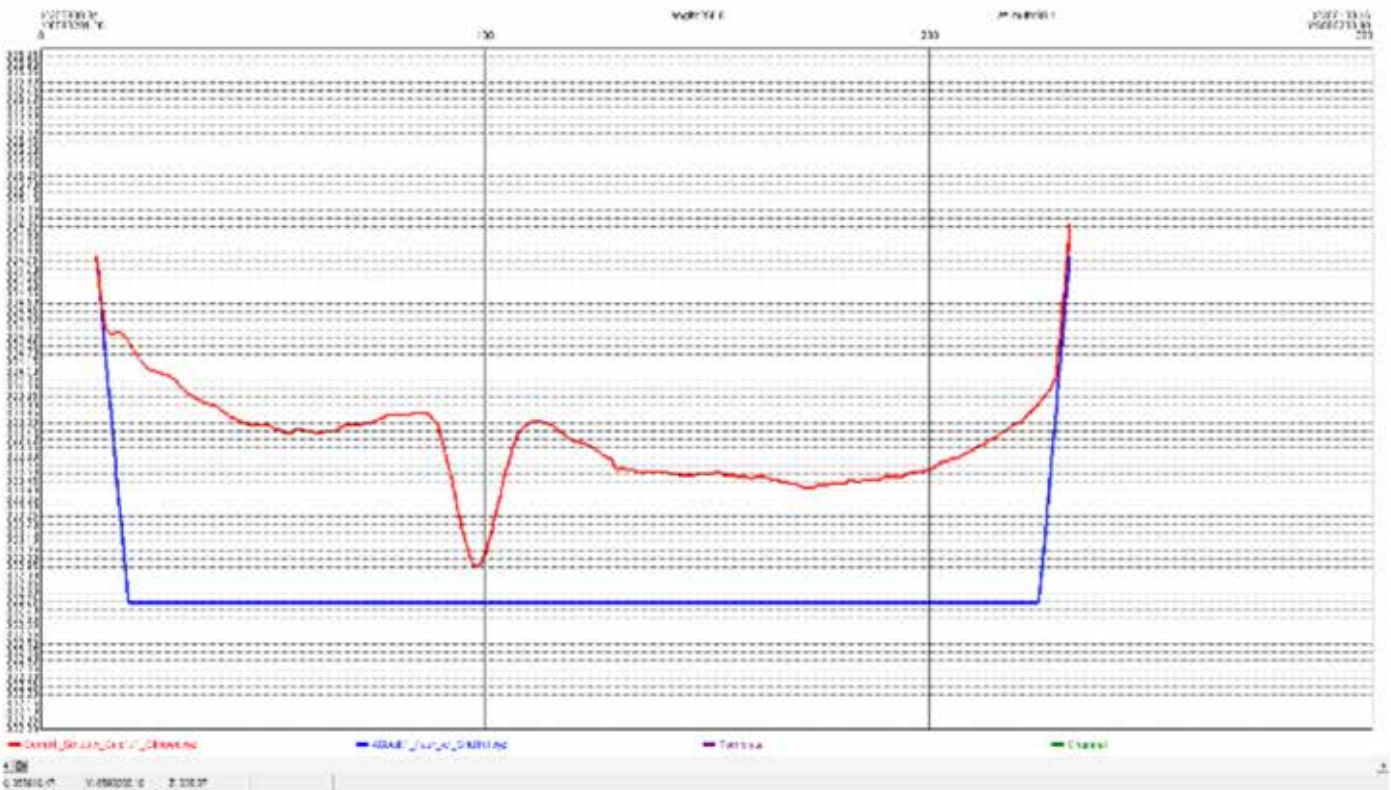
Figure 11: WWPL1 Width Cross Section.

The section across the width of Wastewater Ponding Lagoon 1 in line with the discharge point is shown in Figure 11. The difference in elevation between the sludge surface (red trace) and as-constructed (blue line) demonstrates the scouring taking place at discharge location.

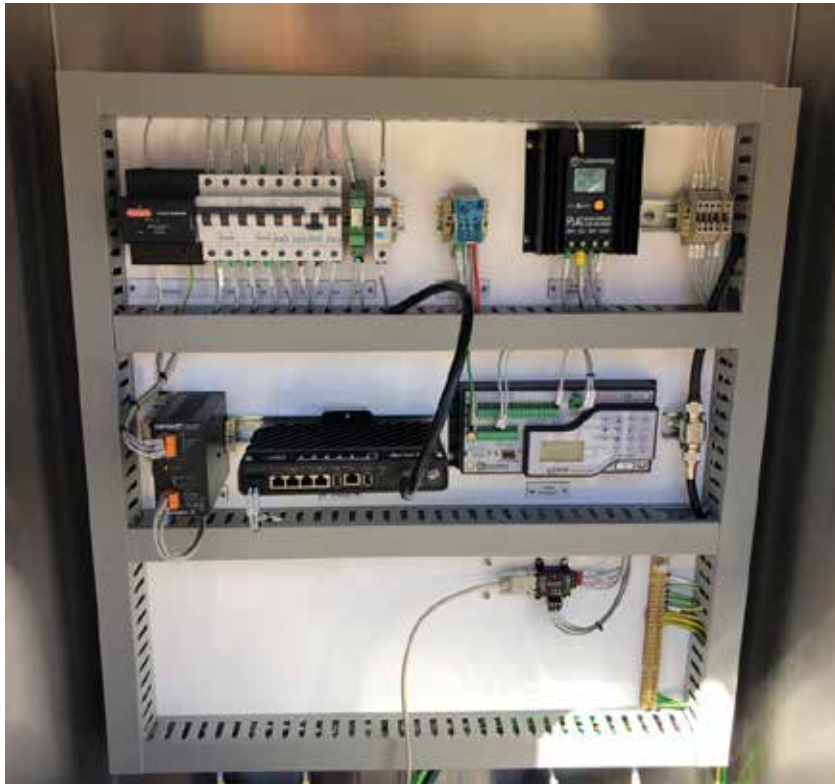
Figure 4: Station backing panel consisting of SCADA RTU, data logger, and solar system.

- SonTek SL1500-3G
- Retractable instrument slide
- SL1500 communications cable
- Campbell Scientific CR850
- Local power enclosure and platform

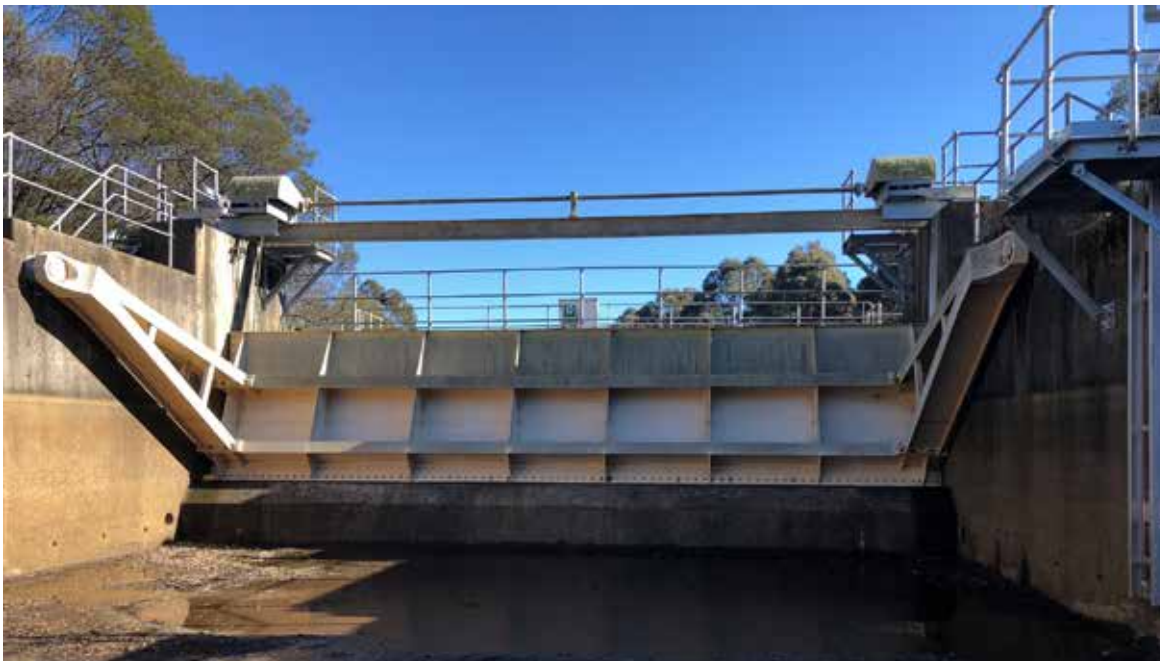
Figure 6: The SL cross section just upstream of the gate.

The SL cross section is located between the Wingecarribee radial gate spillway and rounded approaches of the radial gates flank walls.

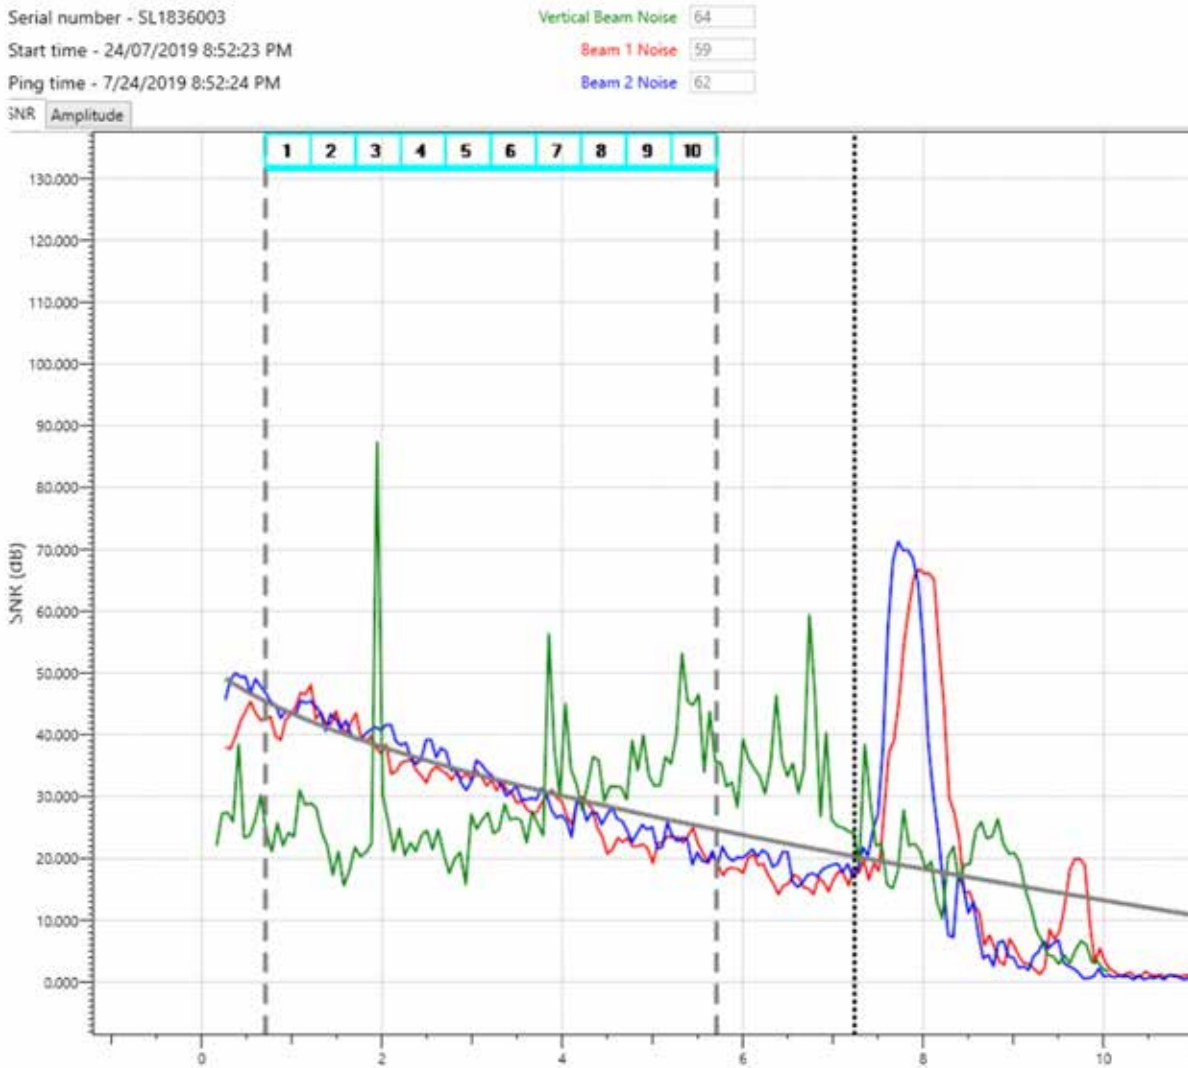
Figure 13: Wildes Meadow SL Beam Check data.

The beam check data illustrates the drop off in signal strength of beams, and shows a strong return when the beams interact with an obstacle. Both beams show strong signal return at approximately 7.2 m, which is consistent with observed channel geometry. No abnormalities were detected.

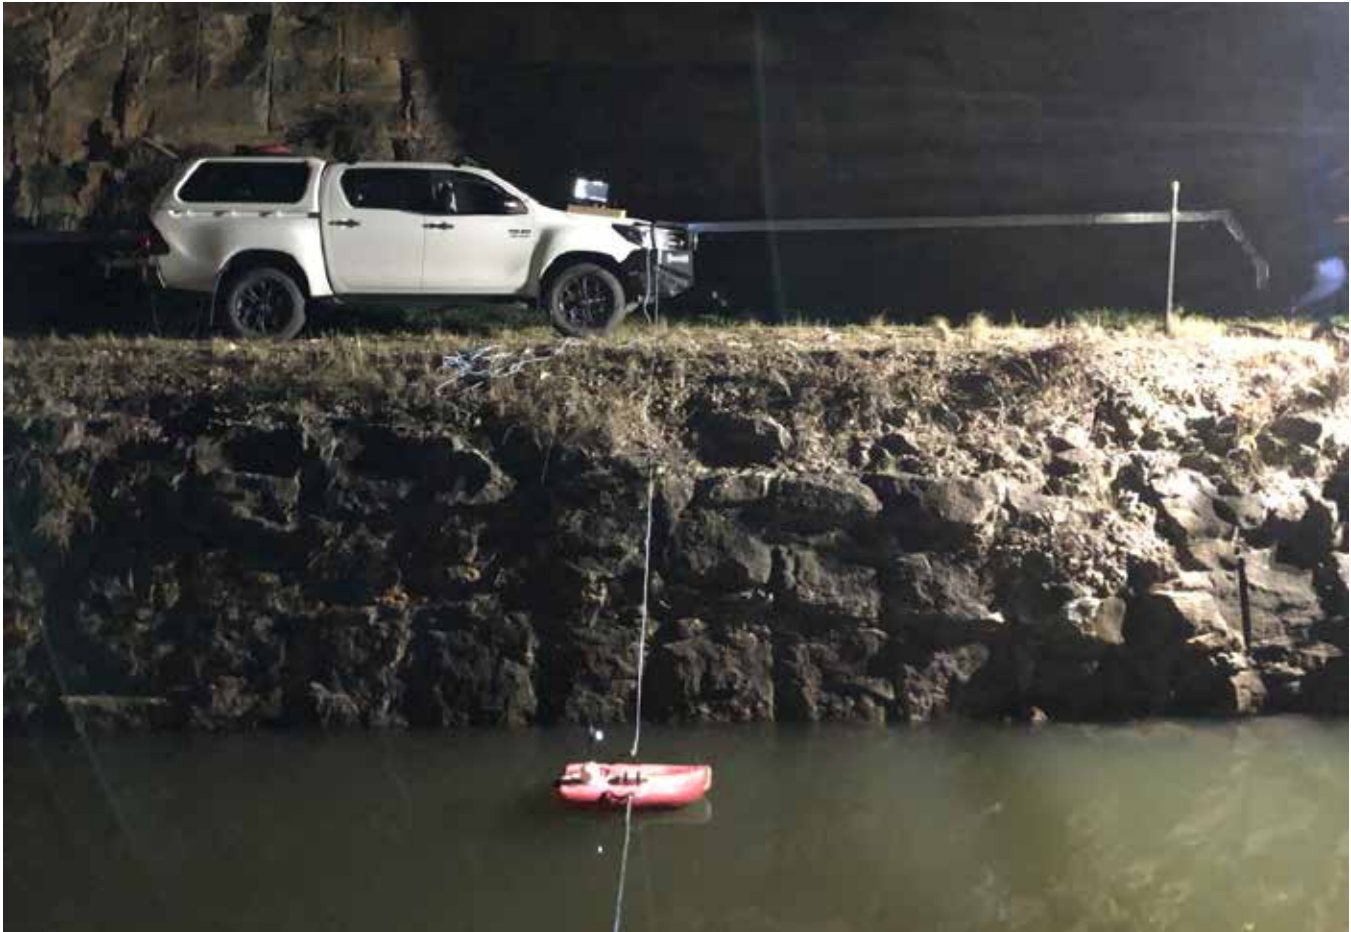
Figure 14: Equipment setup in preparation for pump run measurement.

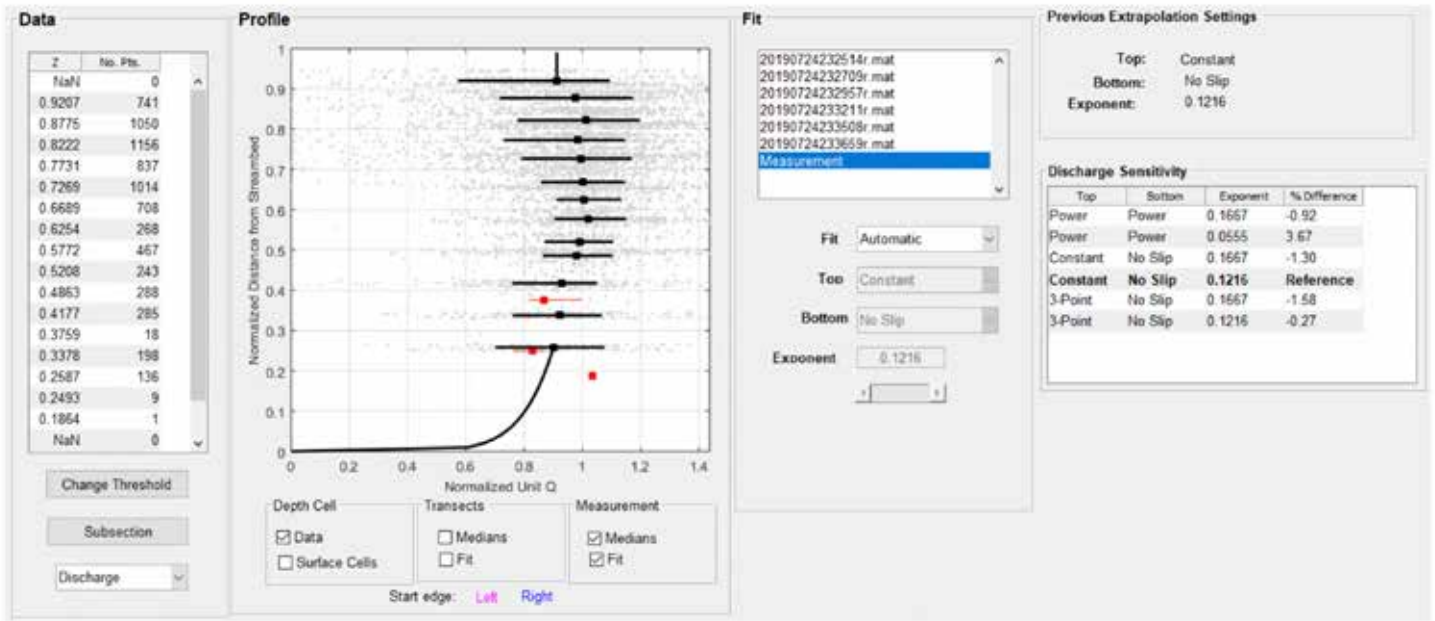
Figure 18: Wildes Meadow Double Pump run.

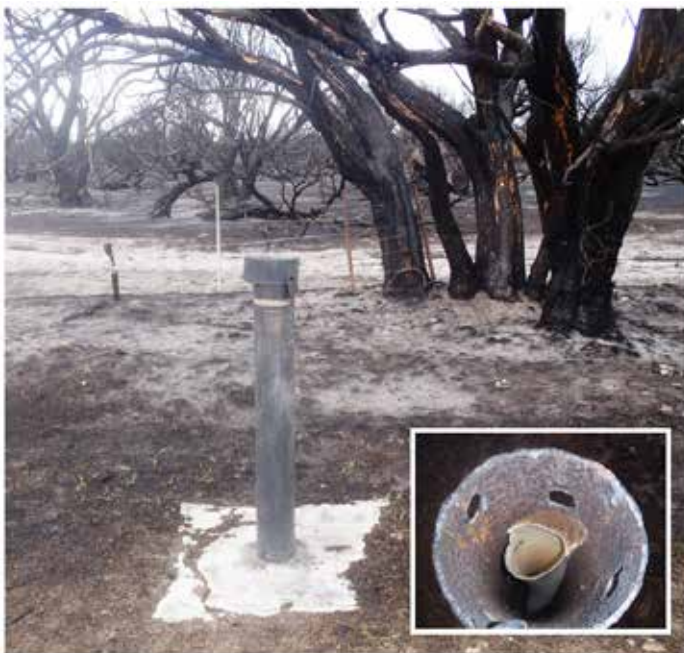
Figure 5: Bore HS24A, Damage to surrounds and inner casing post Waroona Fire.

*"We (DWER) had a total of 7 groundwater monitoring bores damaged to the point of requiring headwork replacements. None required redrilling. Several other bores sustained superficial damage, which only required repainting of the headworks. The bores are monitored on a maximum/minimum frequency (Mar, Apr, May and Sep, Oct, Nov) and repairs were made before monitoring commenced so fortunately no data was lost.*

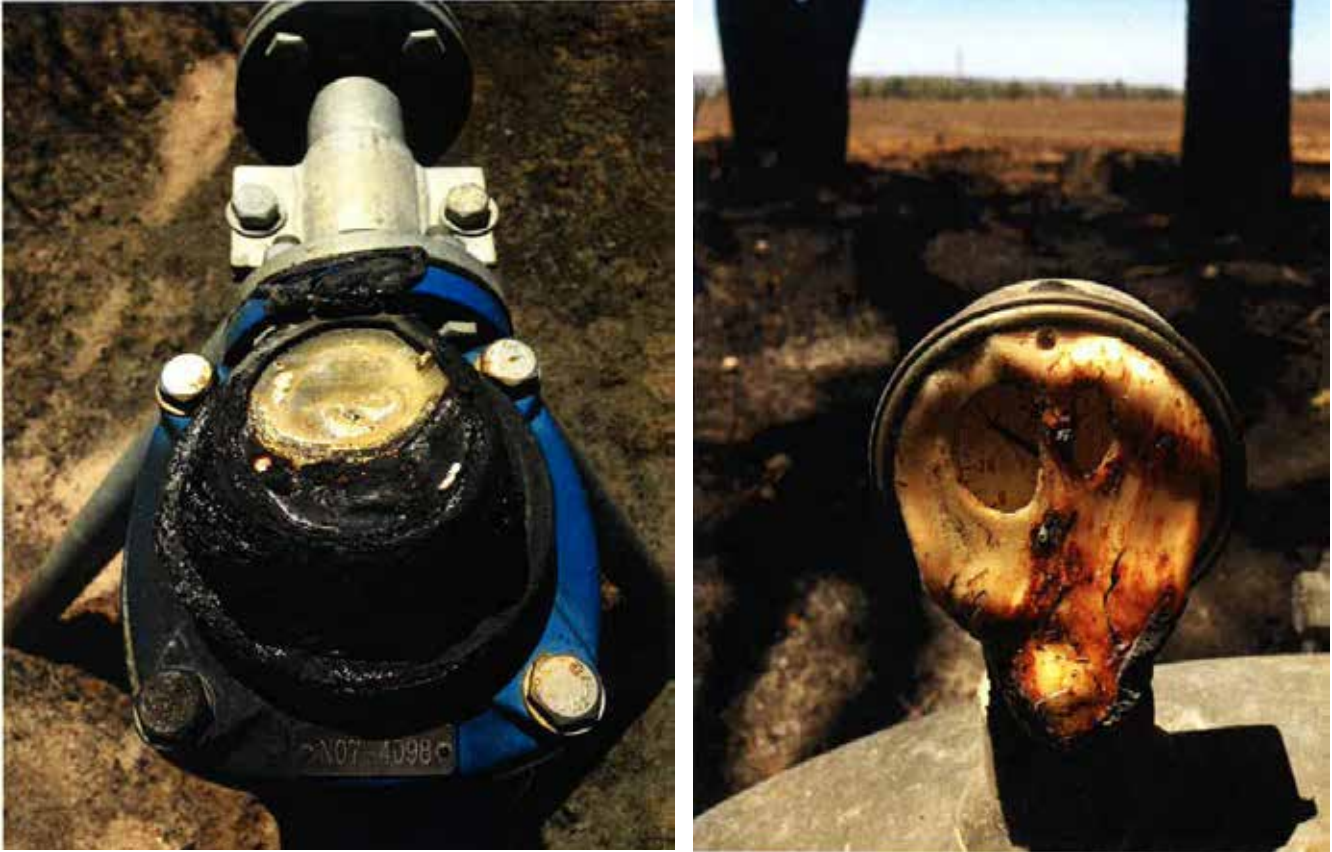
Figure 7: Example of Harvey Water Hydrometric Assets damaged by the Waroona Fire. Left: Mechanical Meter, Right: Pressure Gauge.

*"The impact of the Waroona fire on Harvey Water's monitoring network was primarily in the form of damage to electronic and mechanical meters, pressure gauges and data loggers installed within the Waroona and Harvey Irrigation Districts. The estimated cost to repair these assets in the order of \$30,000" (Kate Duzevich pers. comment, June 2018).*

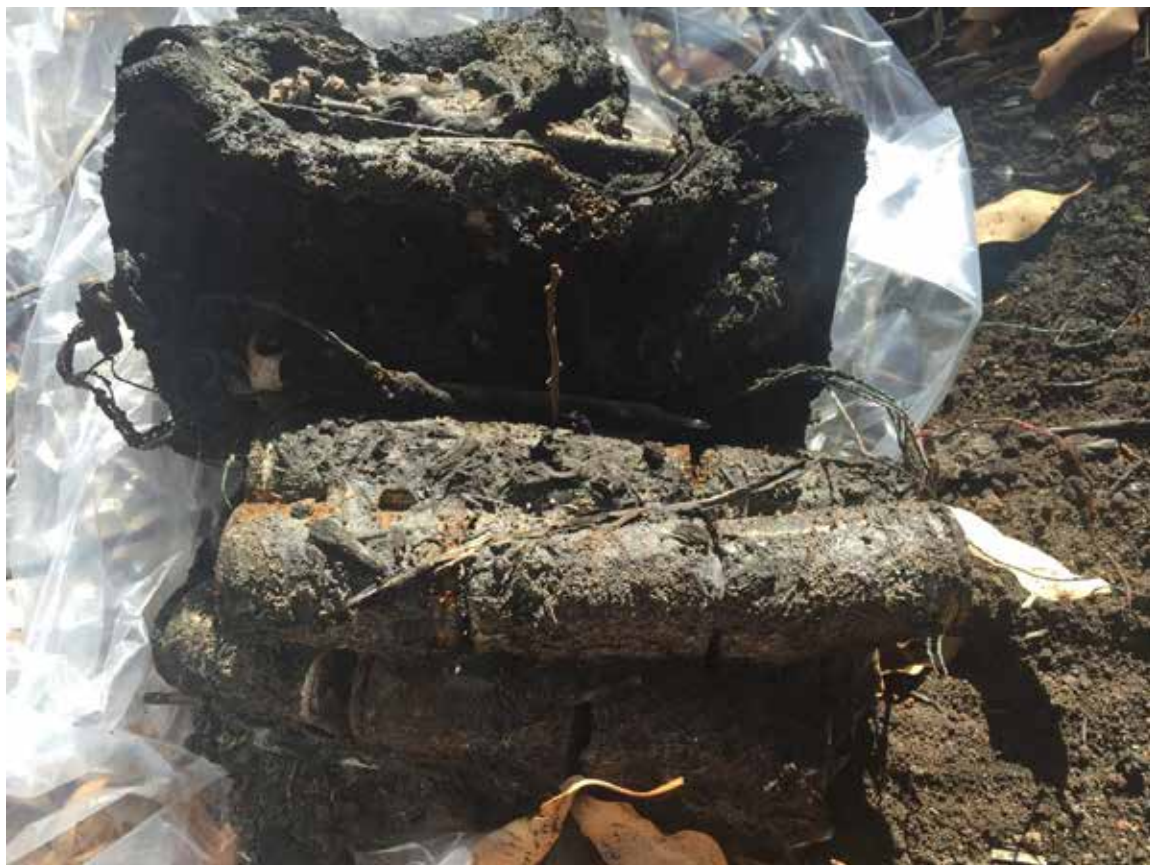
Figure 8: Damaged Logger from 6215W001 — Samson Brook at 1st Below Pipehead.

Overall the damage to the corporation's hydrometric network from the fire and post fire events was limited to \$40,000. The primary damage was to six gauging stations installed in series along the Samson Brook reach. The sites were commissioned in 2014 for the *Samson Brook Environmental Water Provisions* Research Project.

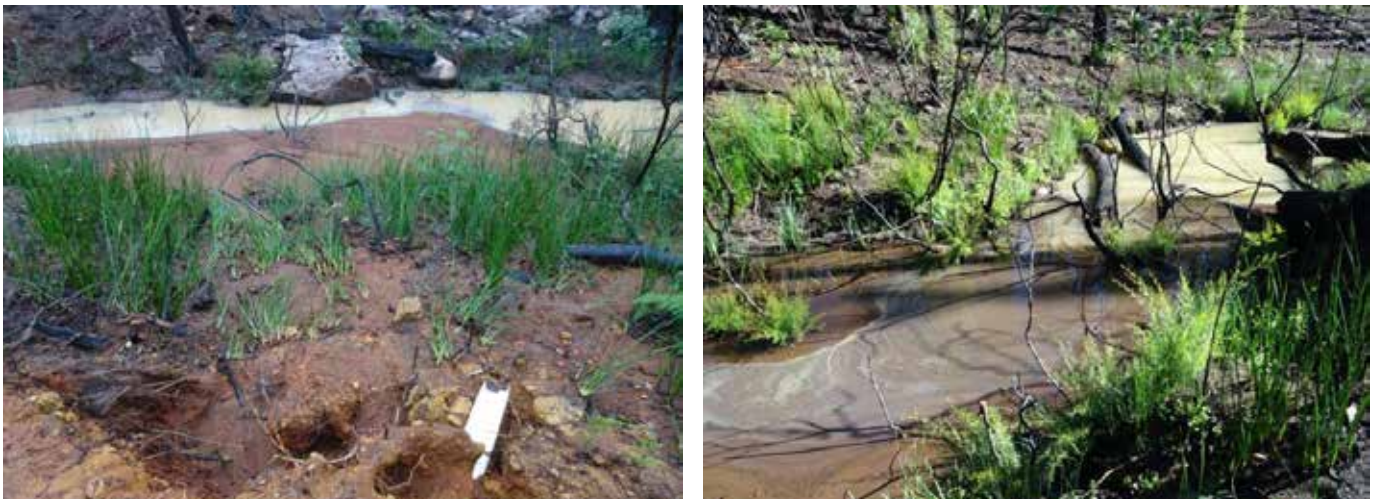
Figure 13: Samson Dam to Pipehead Creek Line. Left: Bank erosion, Right: Suspended sediments in the brook, post rainfall event May 2016 (Images by M. Sturges, Arrona 2016).

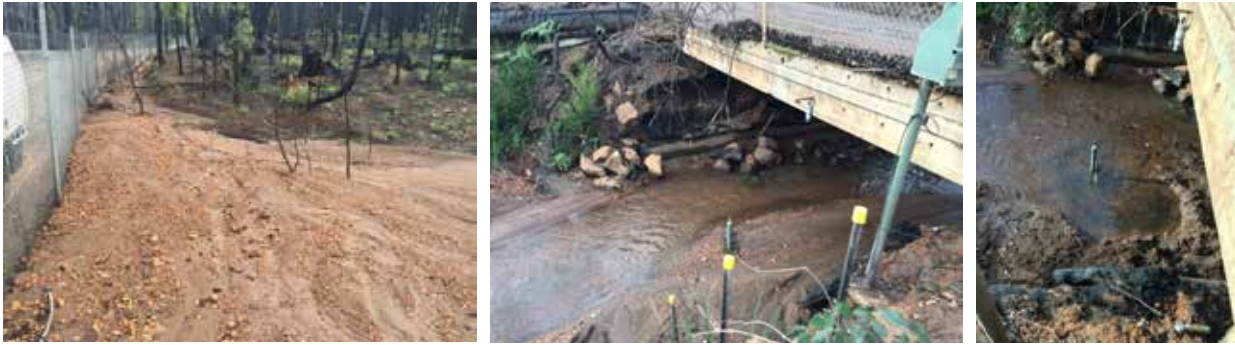
Figure 14: June 2016 (4 months after the fire) 6215W000 Samson Brook at Scarp Rd. Top Left: Hillslope Erosion, Centre: Sediment Build up in the channel, Right: Excavated pool around DO Sensor.

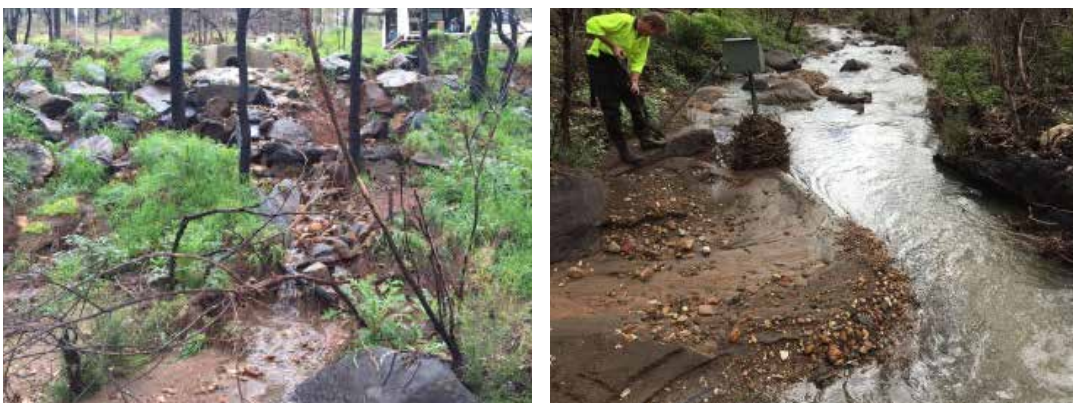
Figure 15: Erosion, Sediment, Debris and Turbid Water at 6215W001 Samson First Below Pipehead June 2016 (4 months after the fire).

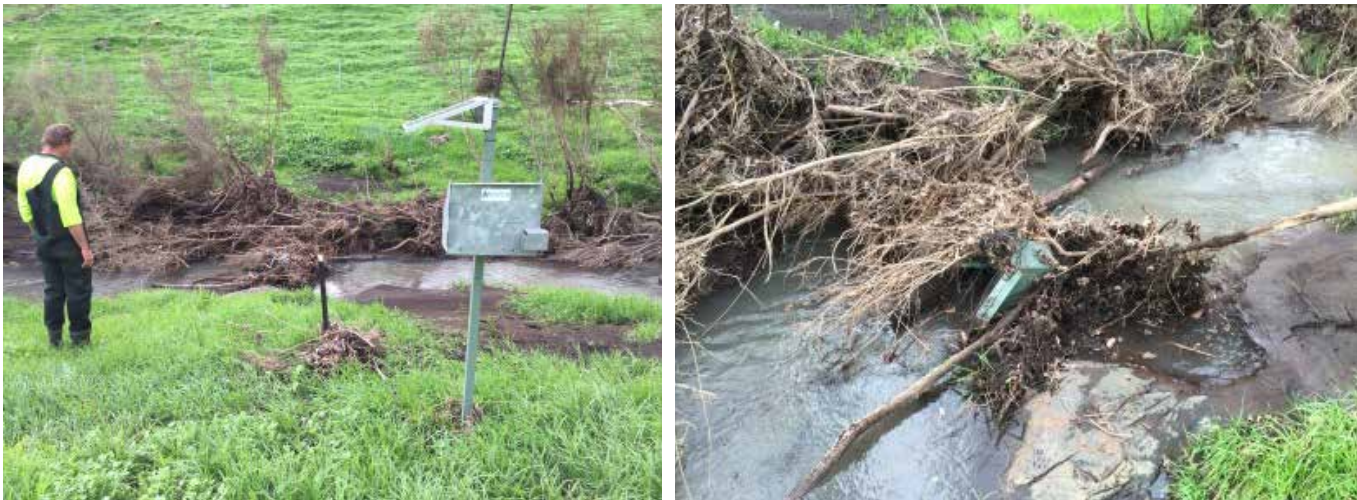
Figure 16: Damage to 6215W002 Samson Brook at Paddock East June 2016 (4 months after the fire).

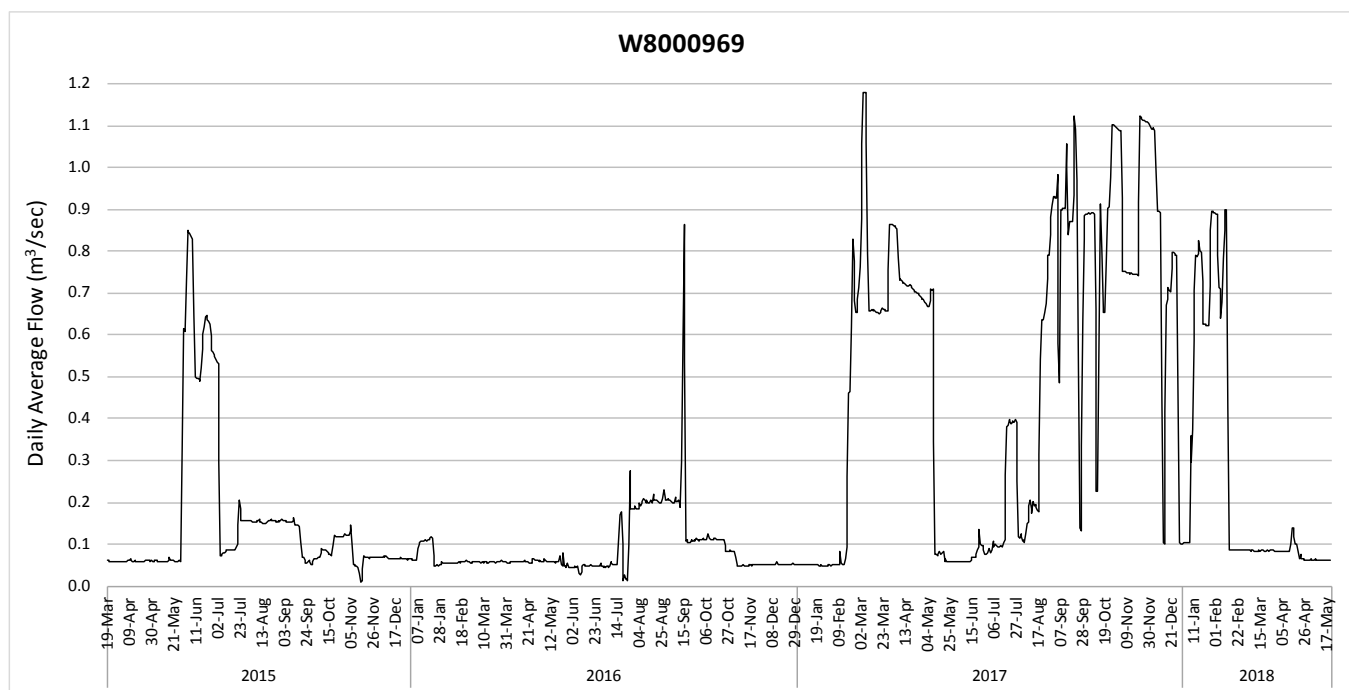
Figure 19: Samson Brook Below Main Dam Average Daily Discharge March 2015 to May 2018 (WRM, 2018).

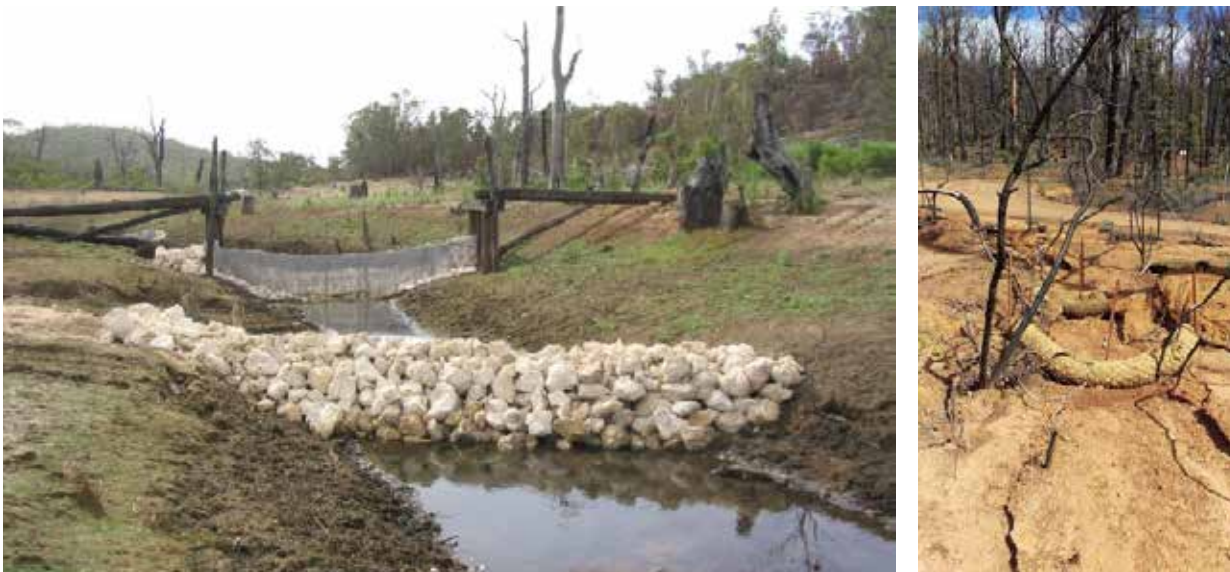
Figure 21: Left: limestone and geofabric sedimentation structures installed in Mundaring Catchment post 2005 Hills fire, Right: Coir Logs installed near 6215W000 Samson Brook at Scarp Rd.

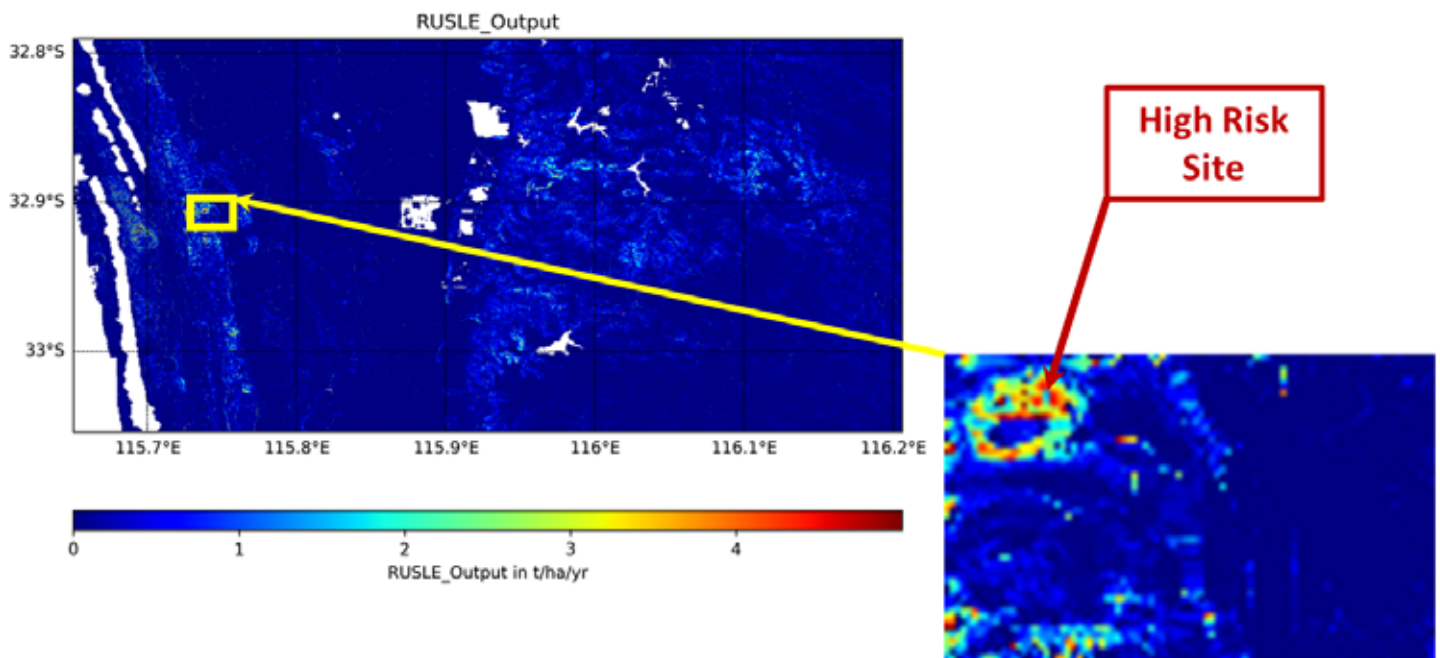
Figure 23: Example of a fire response model output.
